Chicago, Illinois
May 2-7, 2010

Paper C-1-01

MAPPING THE UNDERGROUND INFRASTRUCTURE: LEVERAGING GPS TECHNOLOGY TO LOCATE AND IDENTIFY PROBLEMS

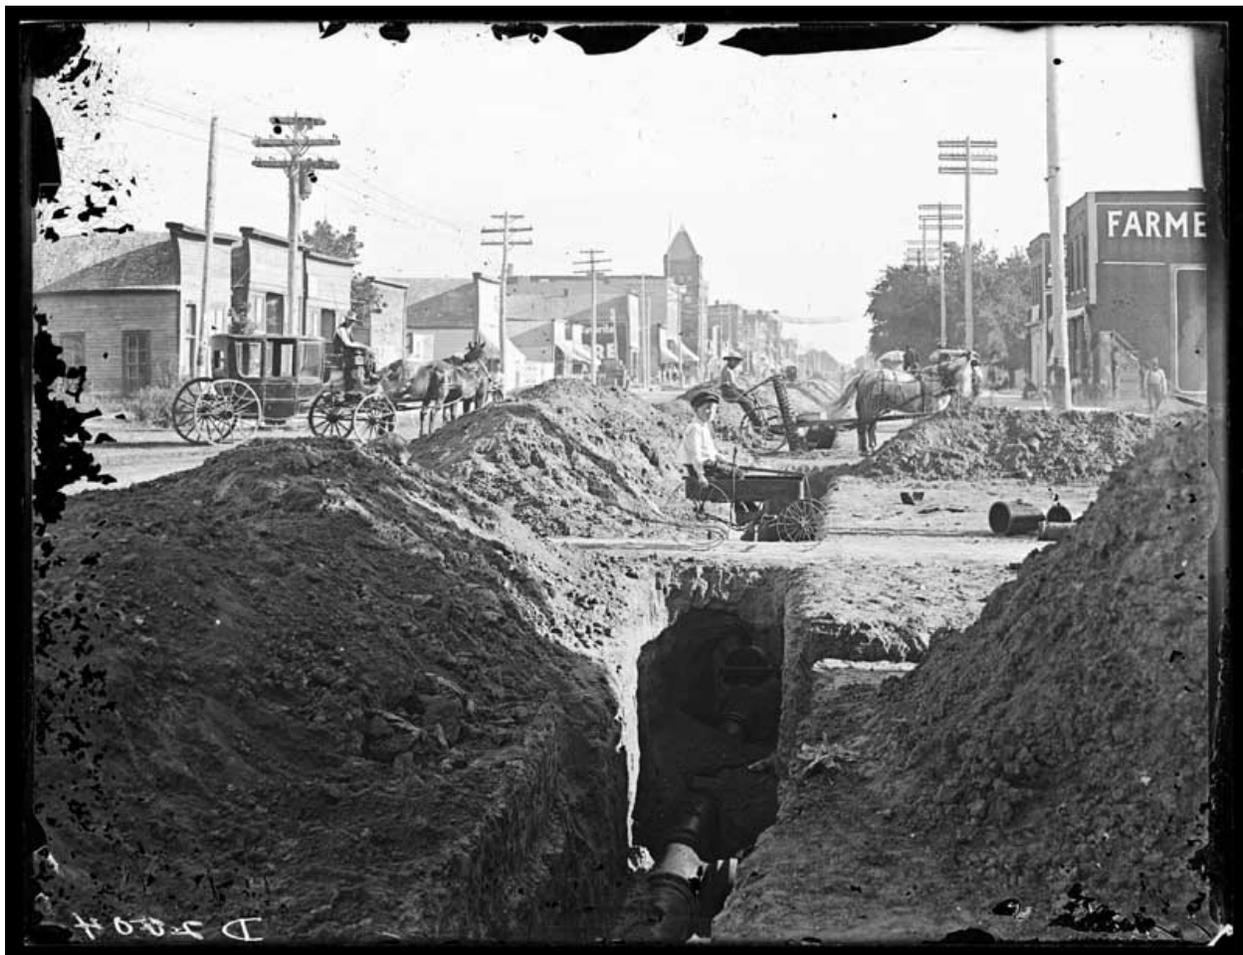
Figure #3: Sewer Construction Circa 1889

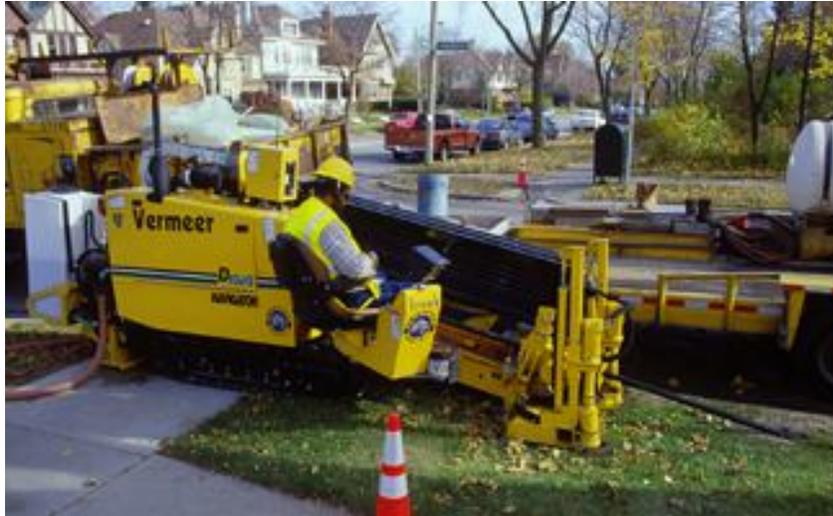
Figure #4: Horizontal Directional Drilling equipment

In addition to poor quality mapping data, the industry is challenged by the use of new “Trenchless” technology methods of construction that involve the widespread use of directional drills, moles and plows. 19th Century hand digging done by immigrant laborers has been replaced by equipment that provides far more economical means to install and replace buried pipelines. The problems arise when these sub-surface tools encounter buried infrastructure and are unable to discriminate between the earth and the pipeline material, and proceed ahead causing damage by “an outside force” to the infrastructure in its path. This incidence is called a “Cross Bore”.

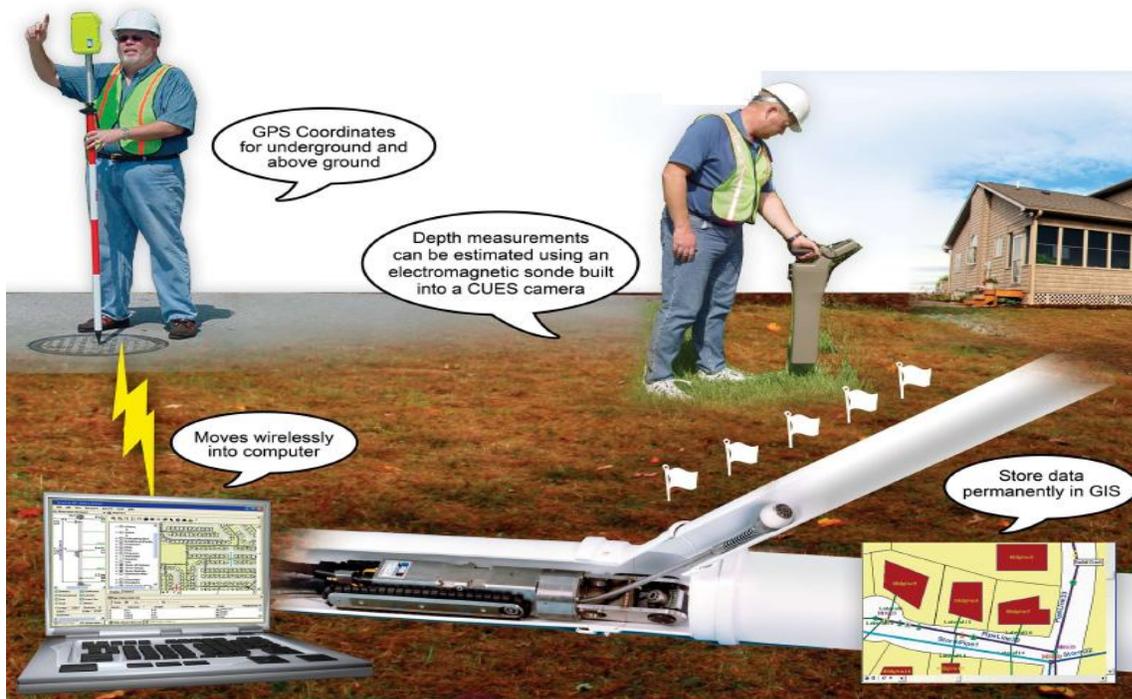
Figure 6: The Technologies Used: GIS Software, Wireless GPS, Digital Video, Sonde and Robotic transporter.

Jointly they decided to use this combination of technologies to meet their goal of collecting accurate sewer lateral line traces with sub-meter accuracy (*centimeter accuracy is possible but was not deemed necessary in this project*). The CCTV inspection vehicles deployed to the area of the city were each provided a GPS receiver, an electromagnetic sonde and receiver, a lateral launch camera and a pipeline inspection software with GIS mapping capabilities.

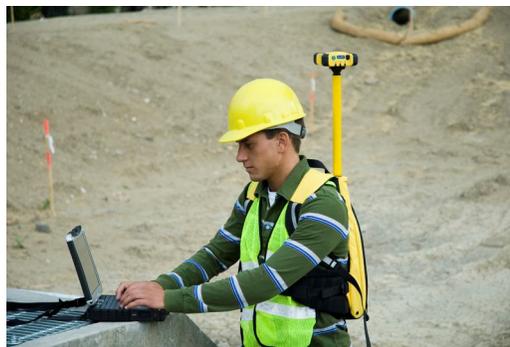
Figure 12 : GPS Backpack kit for Sub-centimeter survey grade data collection (alternative)

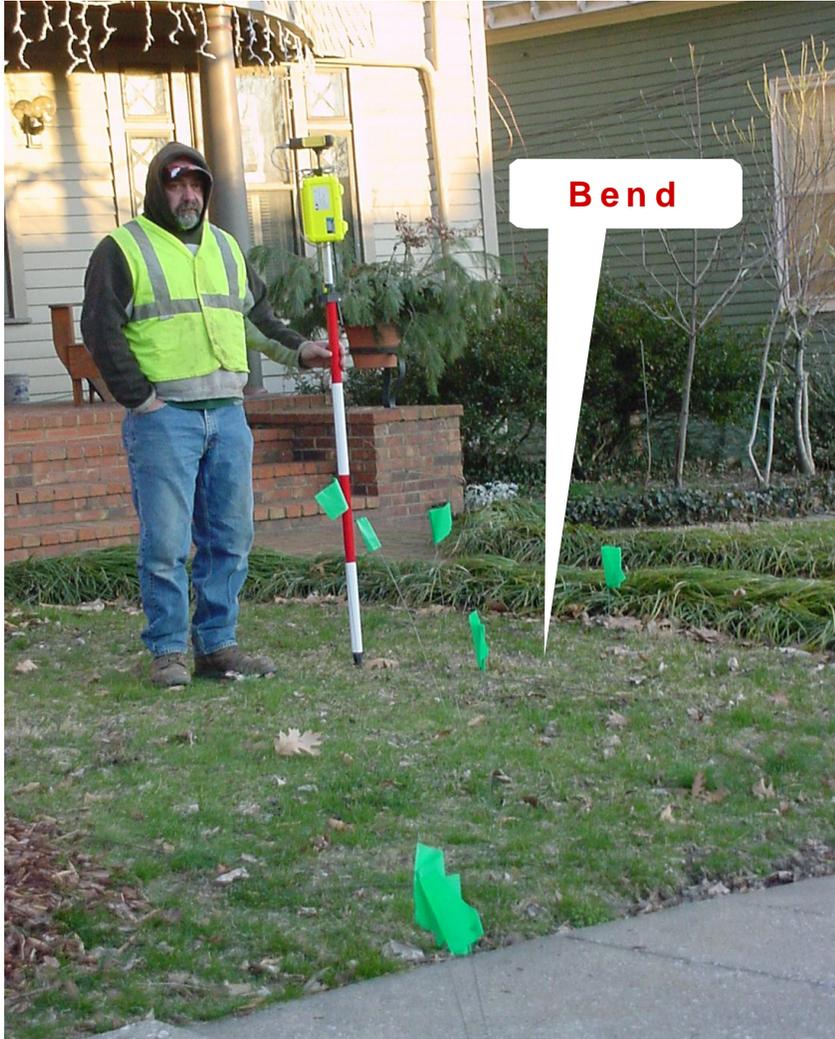
Figure 14 : CCTV Field inspector captures lateral line trace that has an unusual bend in the line

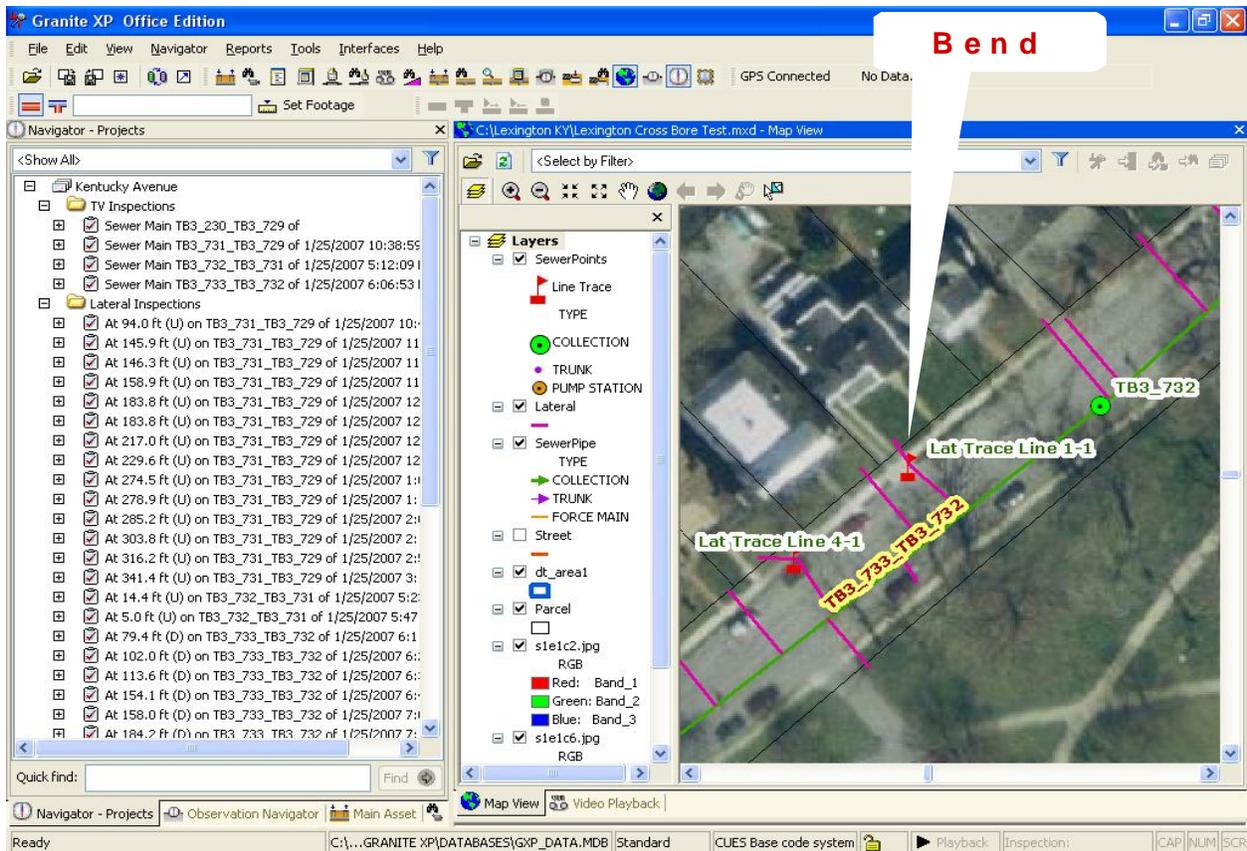
Figure 15: Pipeline inspection software shows a map with multiple sewer Lateral Trace Lines collected in the field, including the property with the unusual bend.
