Inspections for Eliminating Cross Bores

The Canadian Institute Pipeline Safety Conference

**By: Mark Bruce, President,
Cross Bore Safety Association**

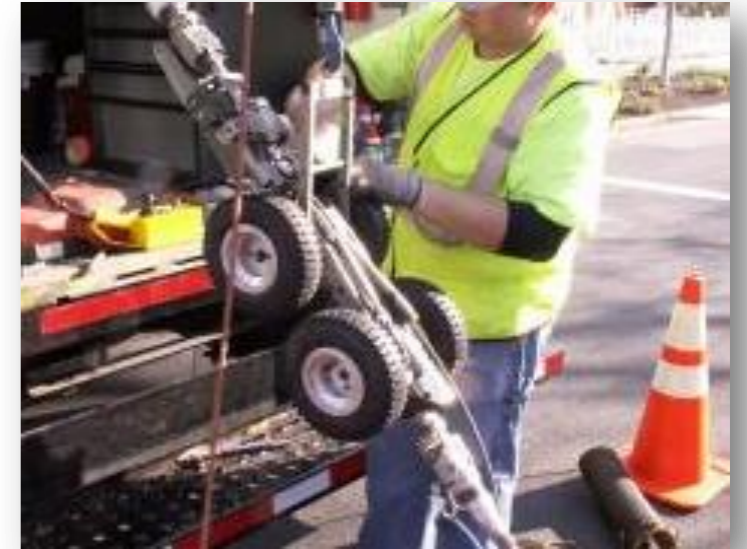
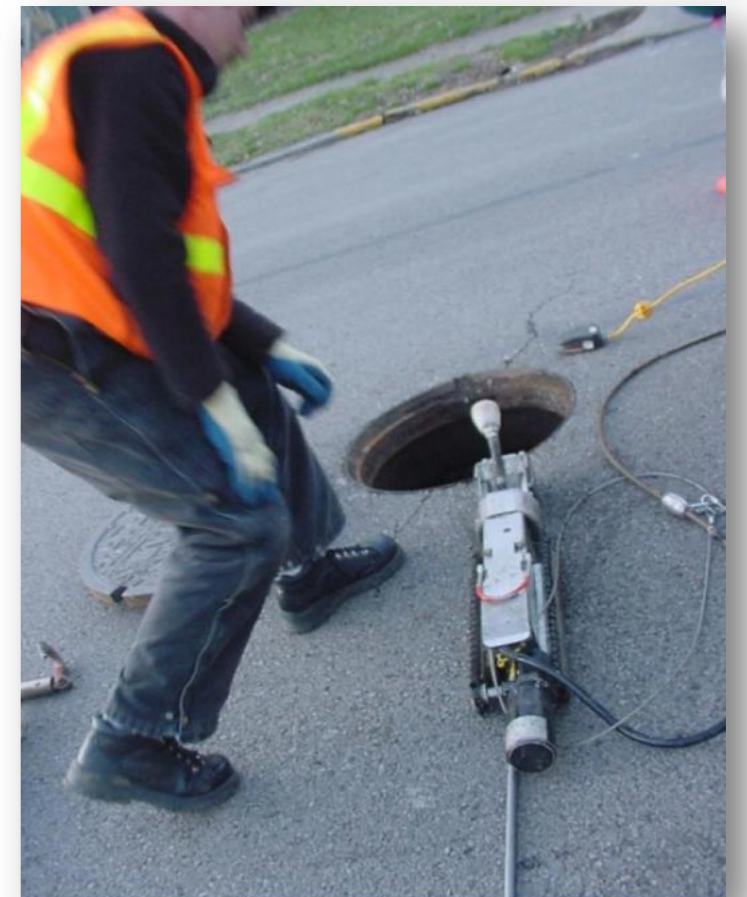
Mainline Cameras w/ Lateral Launch Camera

- Inspect mainline sewers for cross bores through manholes
 - 550 feet from manhole
 - Determines # of laterals, structures may have multiple
- Inspect lateral sewer up to 120 ft from sewer tap

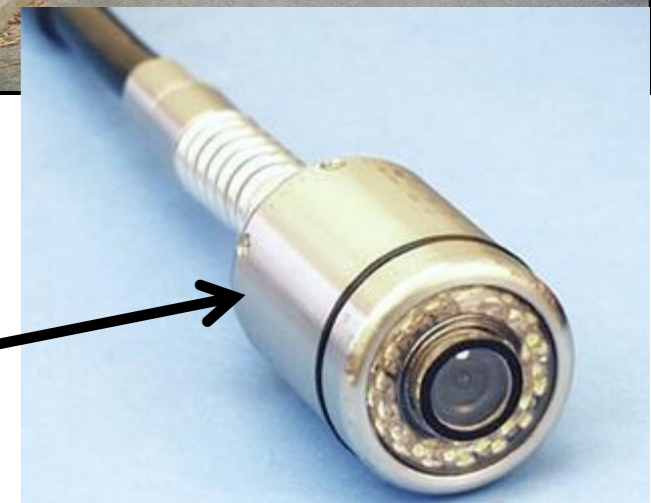
Push Cameras

- Manual push camera on stiff cable
- Distance to 200 ft or more of cable
- Used when mainline robotic cameras do not reach required limits of inspection
- Video, depth and GPS loaded into GIS mapping

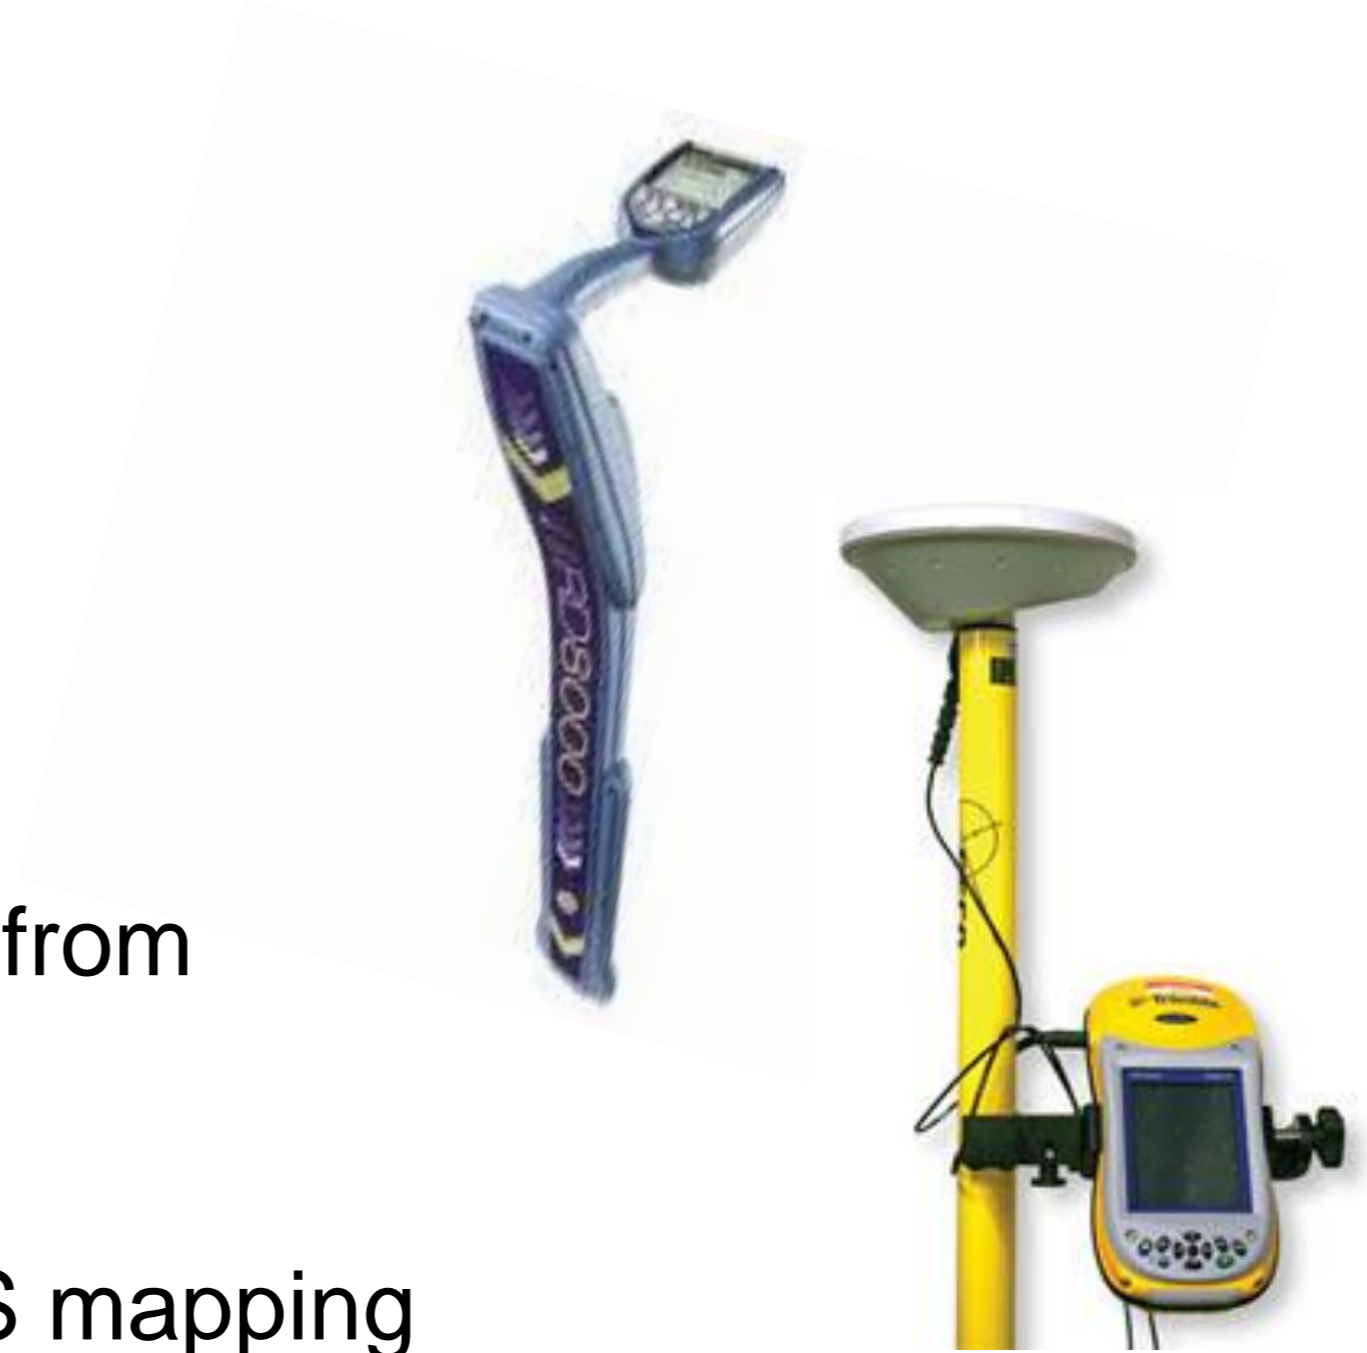
GPS & Sondes

Sonde - Radio Frequency Transmitter & Camera

- Locate
 - XYZ
- Depth of Camera
- Receives signal from sonde
- Recorded into GIS mapping

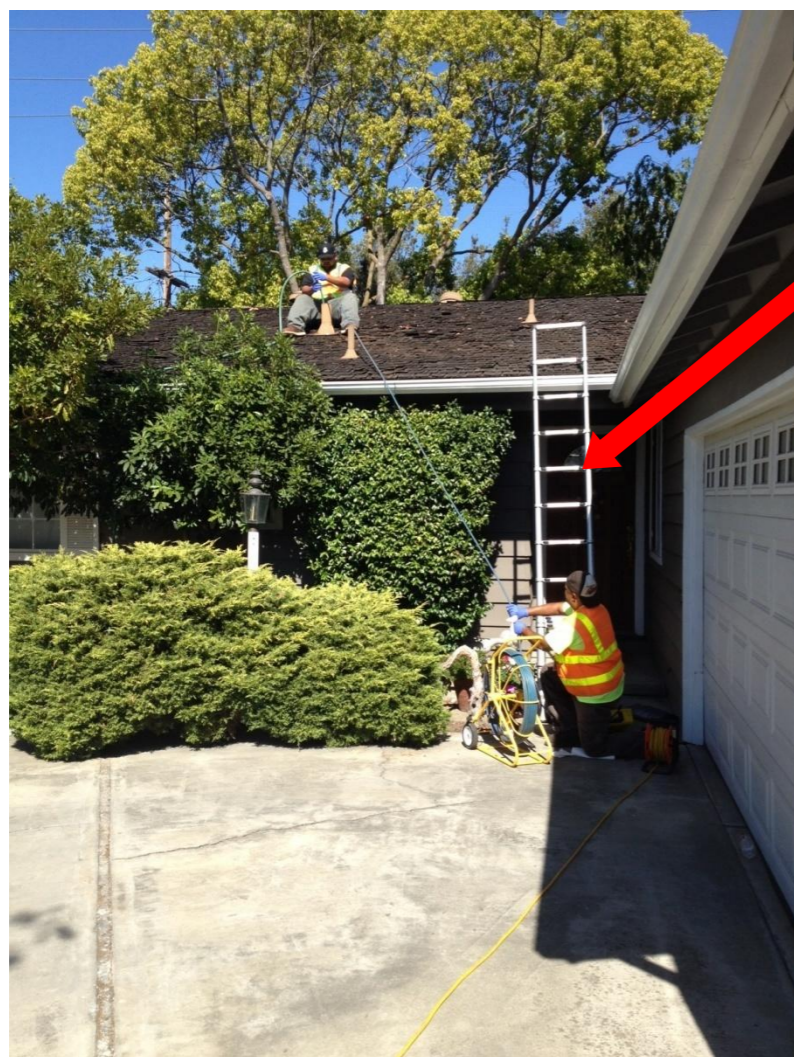
Roof Vent Access

- Usually only 1 story houses
- Permission from owner
- Protect from falls

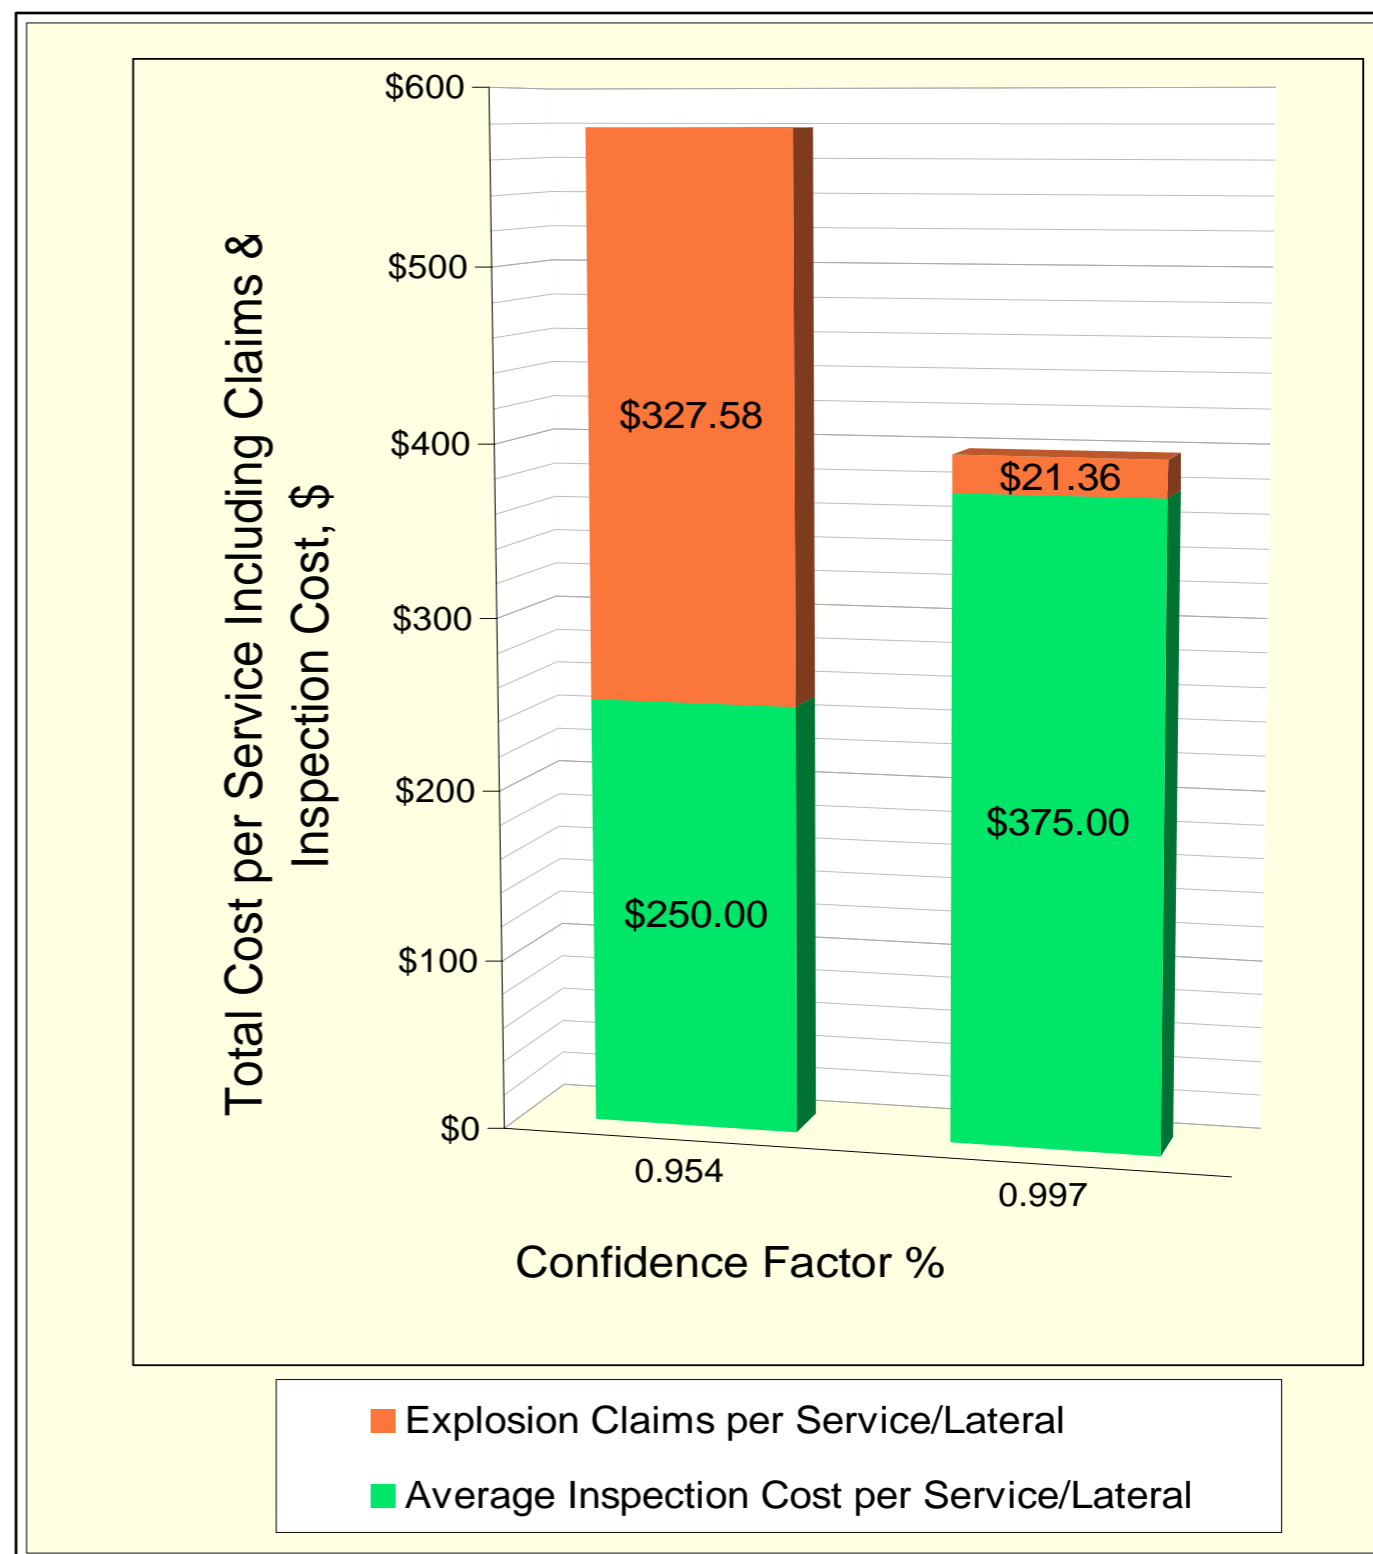
High Confidence Processes Saves \$

Based Upon Total Gas Services in U.S. and Canada = +/- 75,000,000		
Confidence Factor of Locate / Inspection Processes	95.4% (2 σ)	99.7% (3 σ)
Total Cross Bores Expected to be in Project Area	267,000	267,000
Cross Bores Expected to be NOT Found	12,288	796
Cross Bores Not Found & Expected to Result In Explosion Claims, expect 20% <u>will</u> result in explosion.	2458	159
Expected \$ Cost of Cross Bore Explosion Claims	\$24,580,000,000	\$1,590,000,000
Explosion Claims per Total Services in Project Area	\$328	\$21
Average Inspection Cost per Lateral, includes in-house and contractor costs	\$250	\$375
Total Apparent Cost per Service/Lateral	\$578	\$396
Net Cost Savings, 2 σ vs. 3 σ	\$13.6 Billion <u>Savings</u> & <u>Many Lives</u>

- Net cost of high confidence work is less expensive¹.
- Higher percentage of explosions from lower confidence processes.
- Net savings US\$13.8 Billion

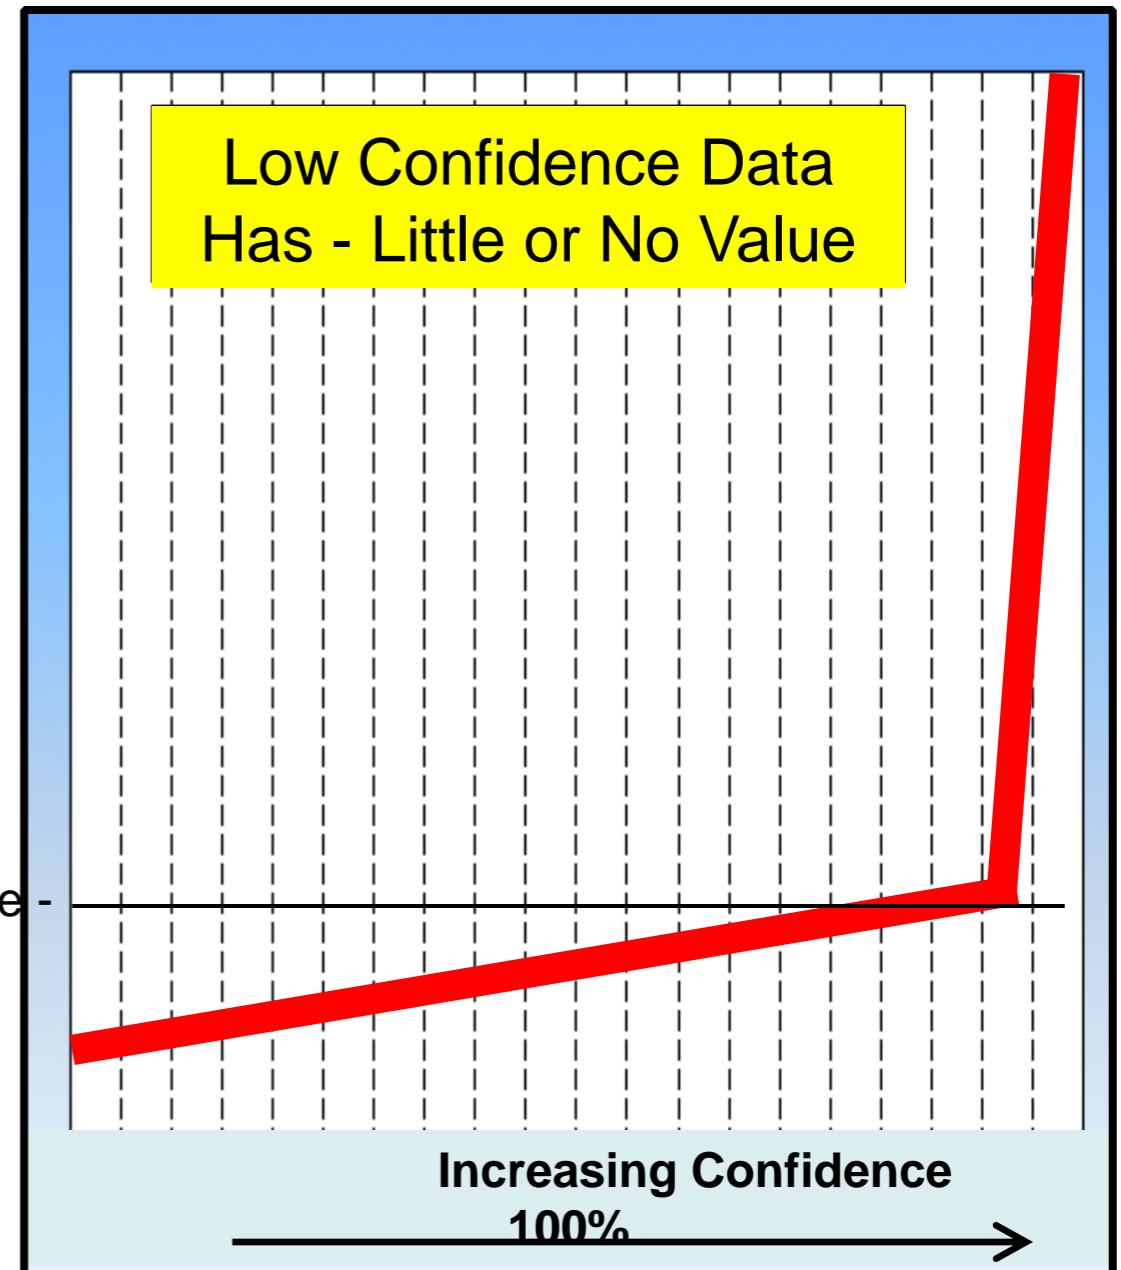
Value Increases with Higher Confidence Processes

- Low confidence results create false security
- Low confidence results may have negative value
- Low quality work may have to be completely reworked.

100% Value -

0 Value -
