# **NARUC Summer Meeting**

**Pipeline Safety:**

**Cross Bores - The Next Safety Frontier**

**By: Mark Bruce, President,  
Cross Bore Safety Association**

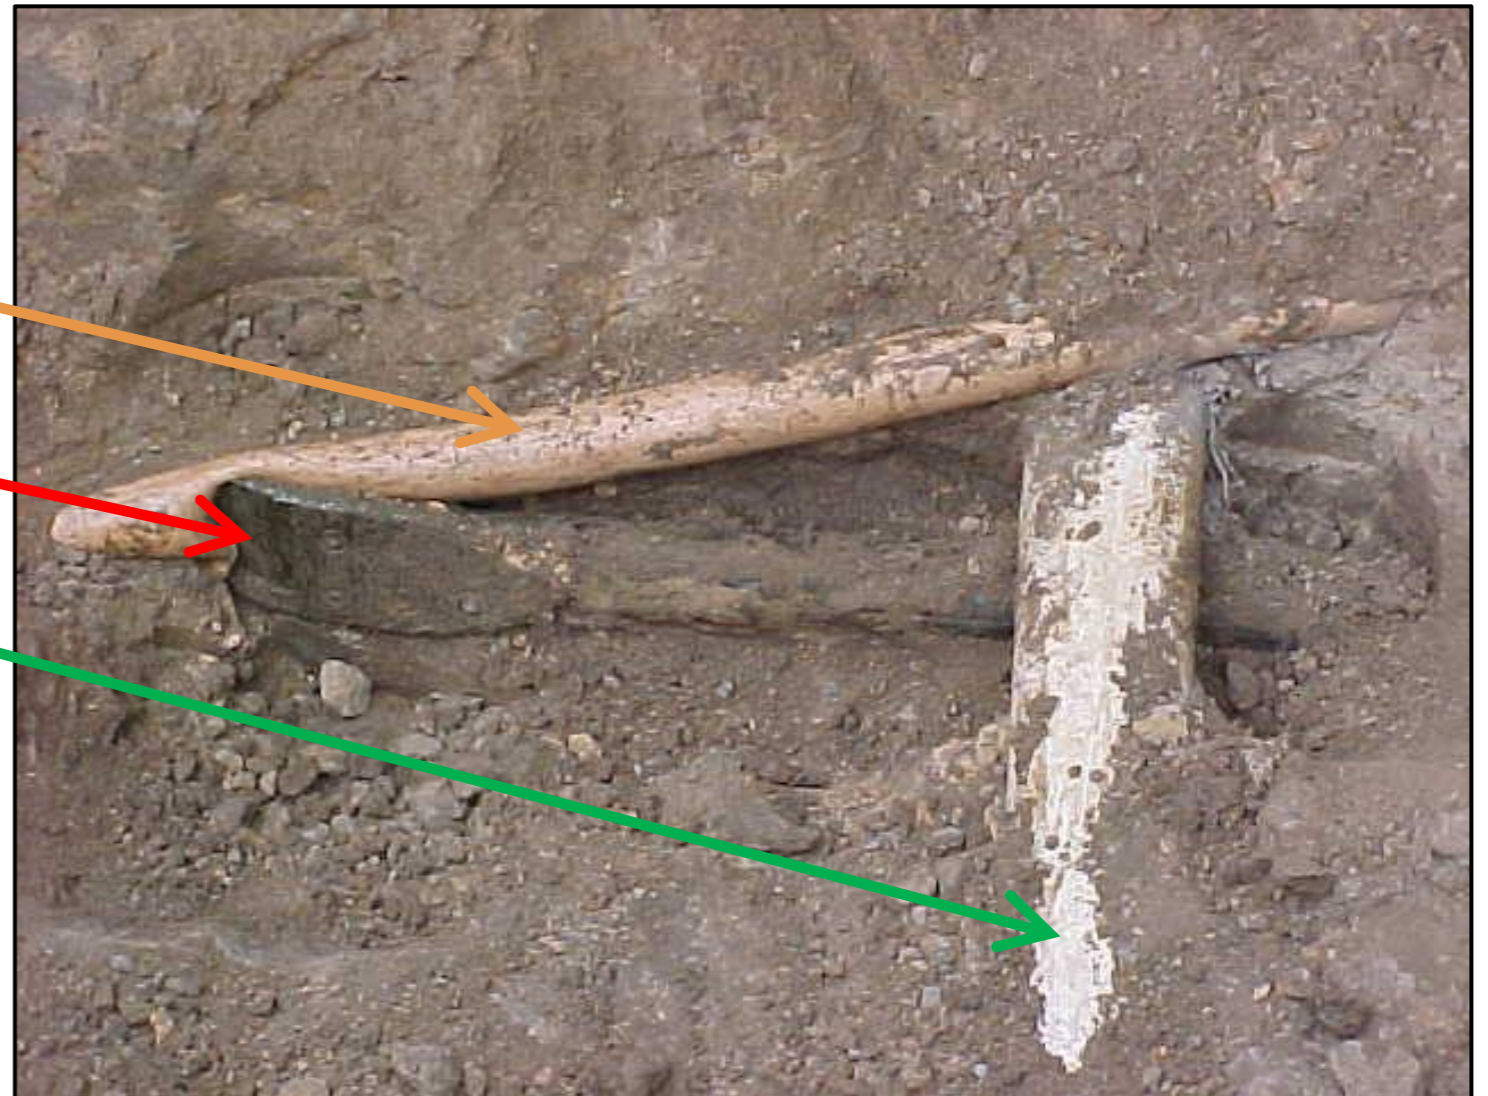
# Class 2 Cross Bore

Gas line  
HDD tool  
Sewer to house

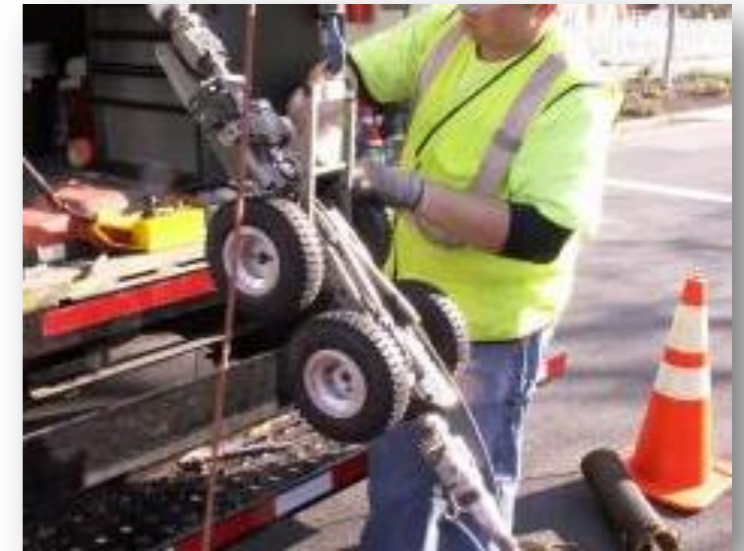
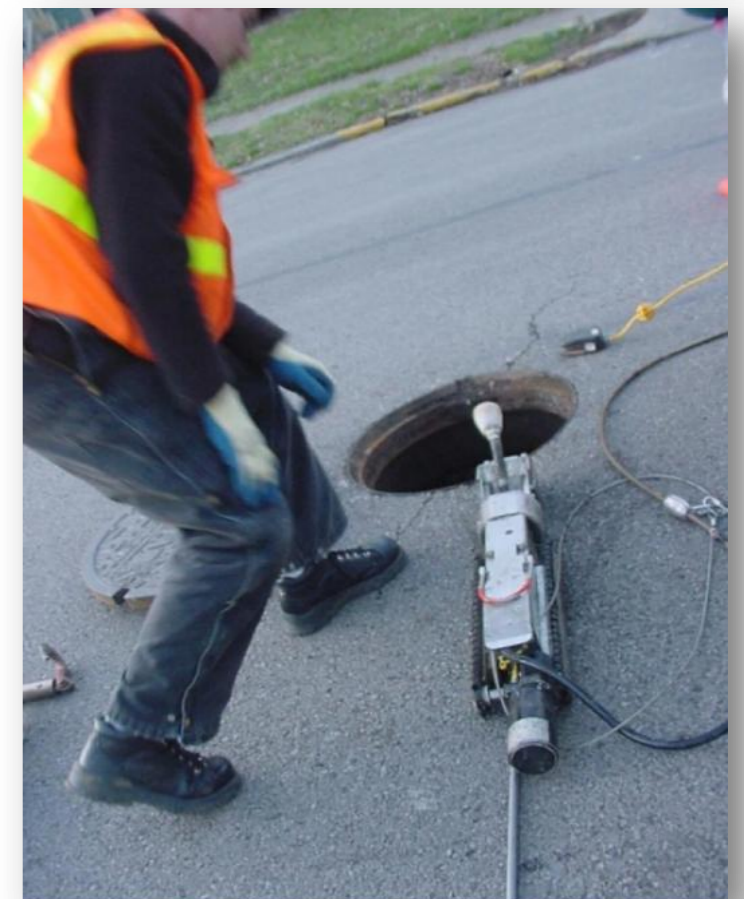
# Mainline Cameras w/ Lateral Launch Camera

- Inspect mainline sewers for cross bores through manholes
  - 550 feet from manhole
  - Determines # of laterals, structures may have multiple
- Inspect lateral sewer up to 120 ft from sewer tap in good conditions

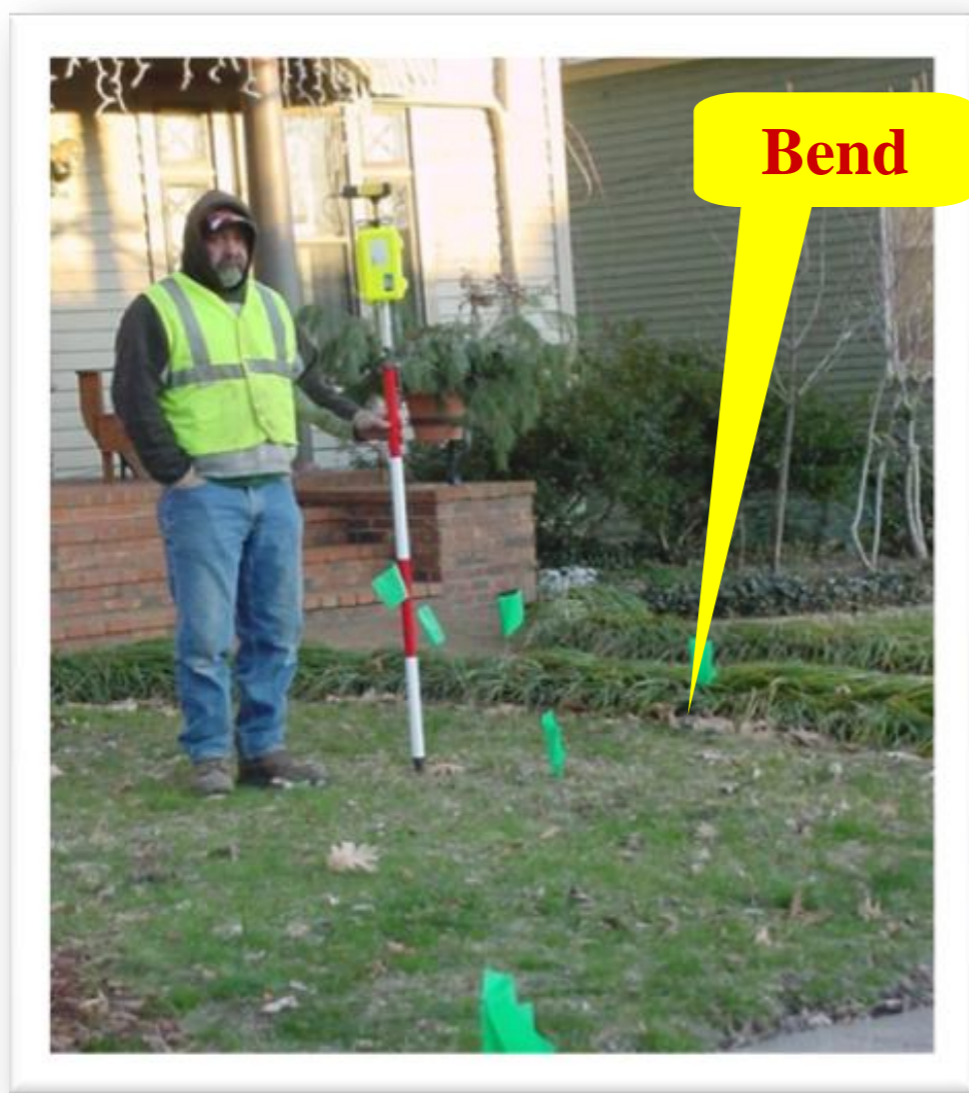
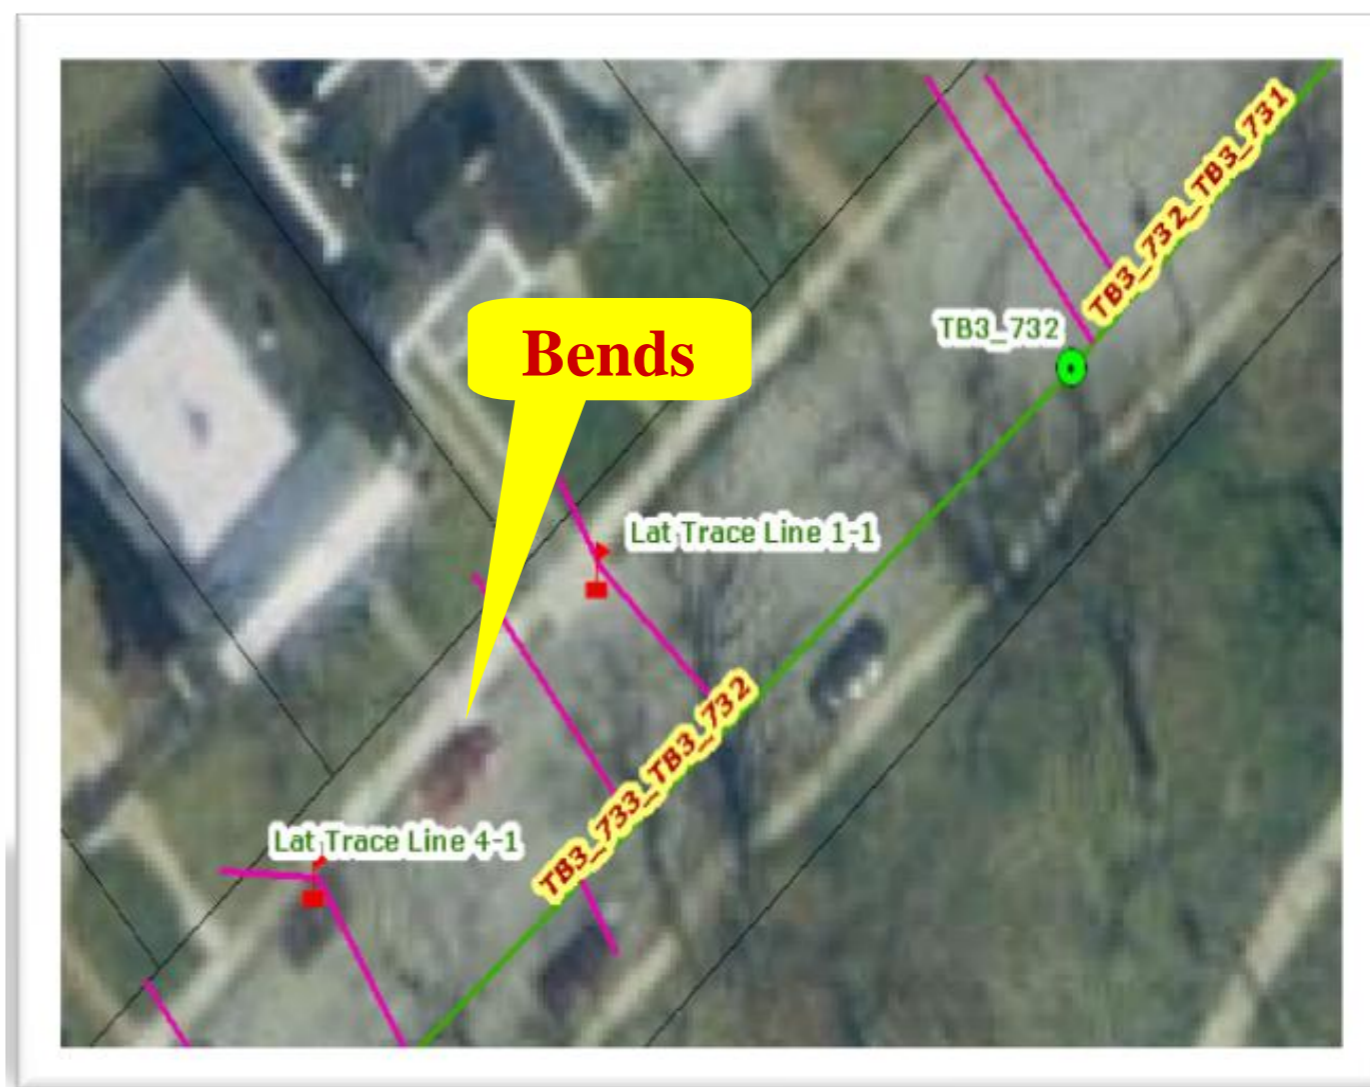
# Lateral Line Traces could remain flagged / spray painted until Gas Line installation crews arrive...

This trace line has bends in the line...which are now reflected in GIS

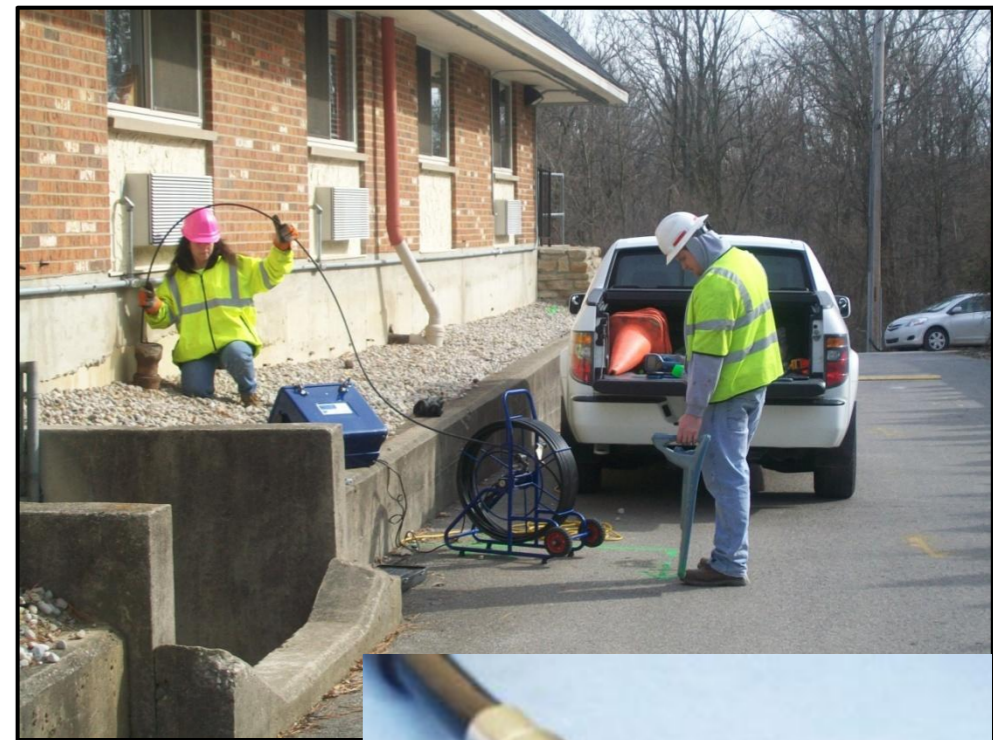
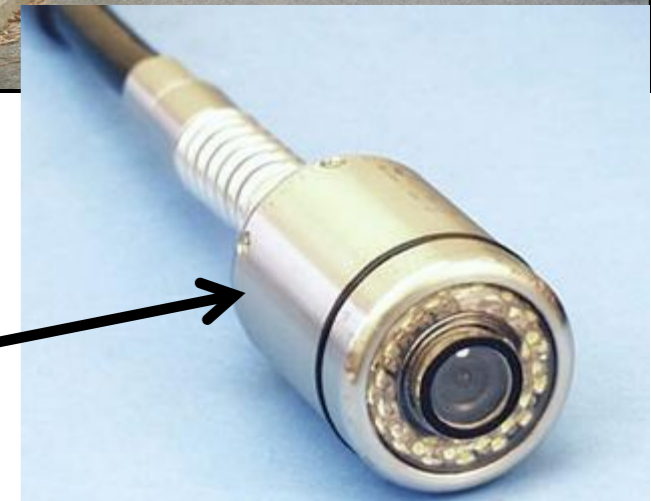
# Push Cameras

- Manual push camera on stiff cable
- Distance to 200 ft or more of cable
- Used when mainline robotic cameras do not reach required limits of inspection
- Video, depth and GPS loaded into GIS mapping

Sonde - Radio Frequency Transmitter & Camera

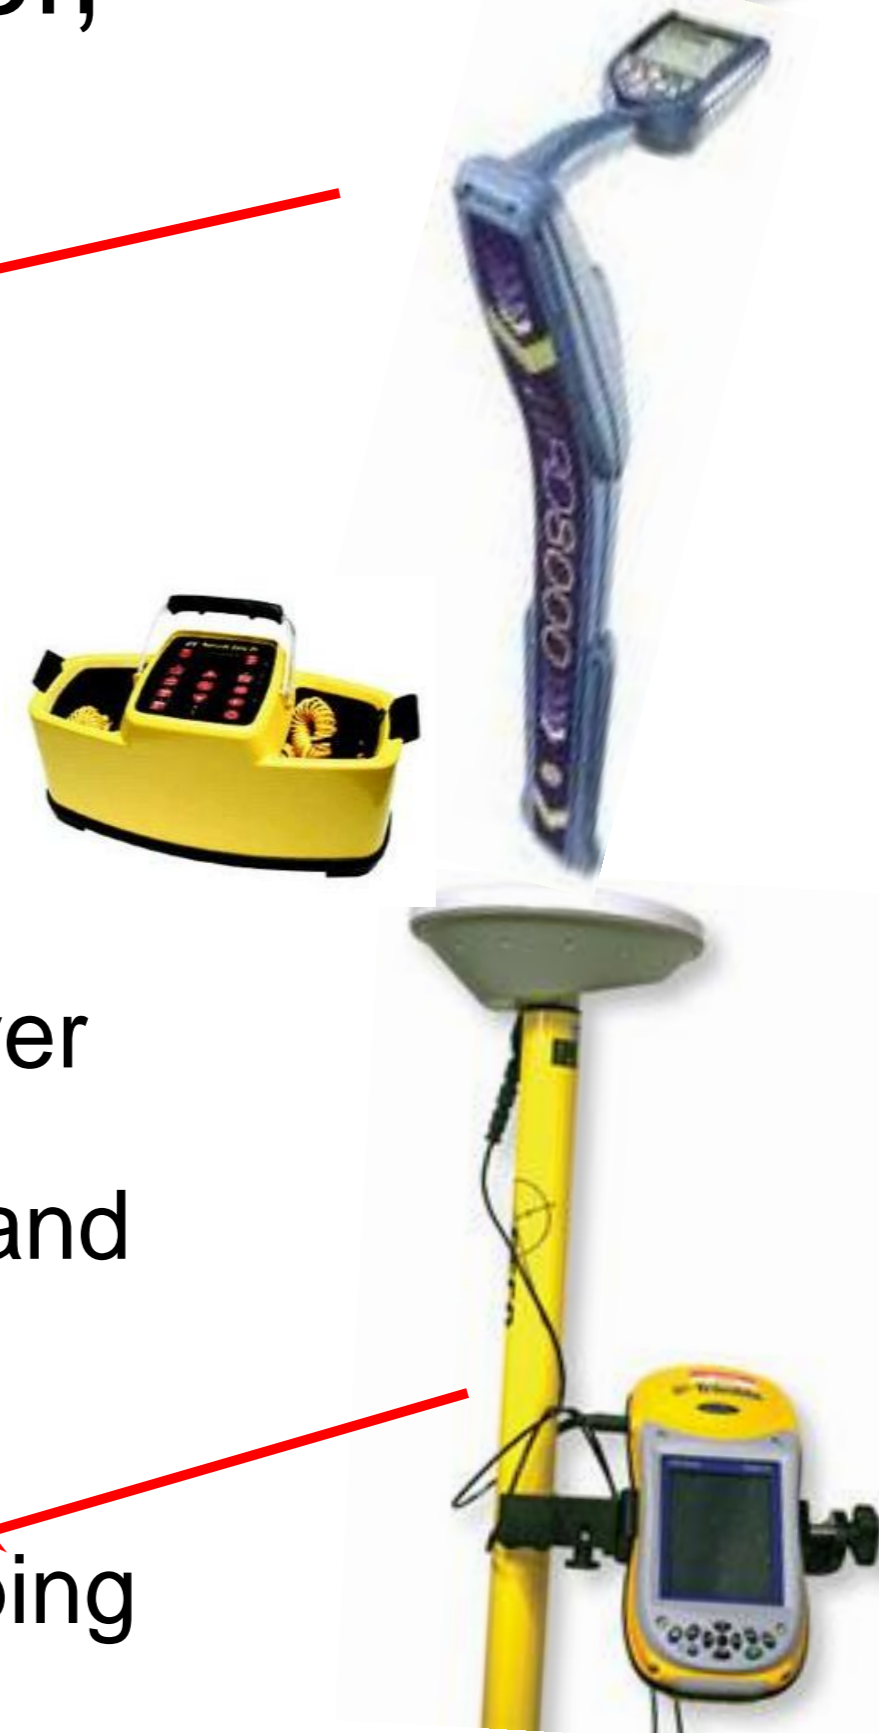
# Locator, Frequency Generator, Sonde & GPS

- Locator - horizontal and vertical
- Sonde - (behind camera) transmits to above ground walk over receiver
- Frequency induced (energized) in tracer conductor transmits to receiver
- Receives signal determines depth and horizontal position of signal
- GPS records location for GIS mapping

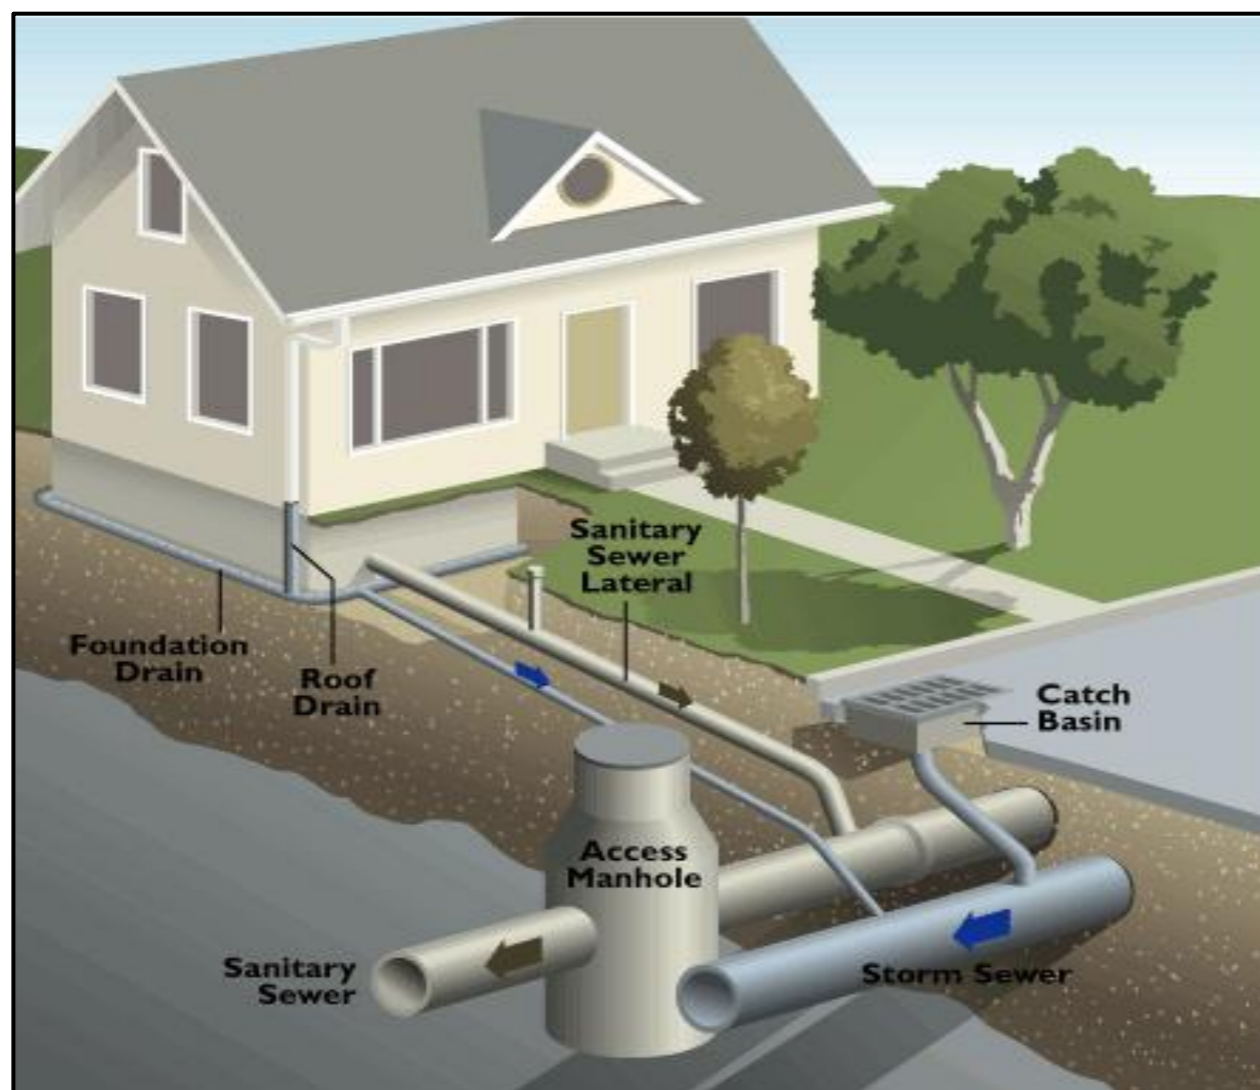
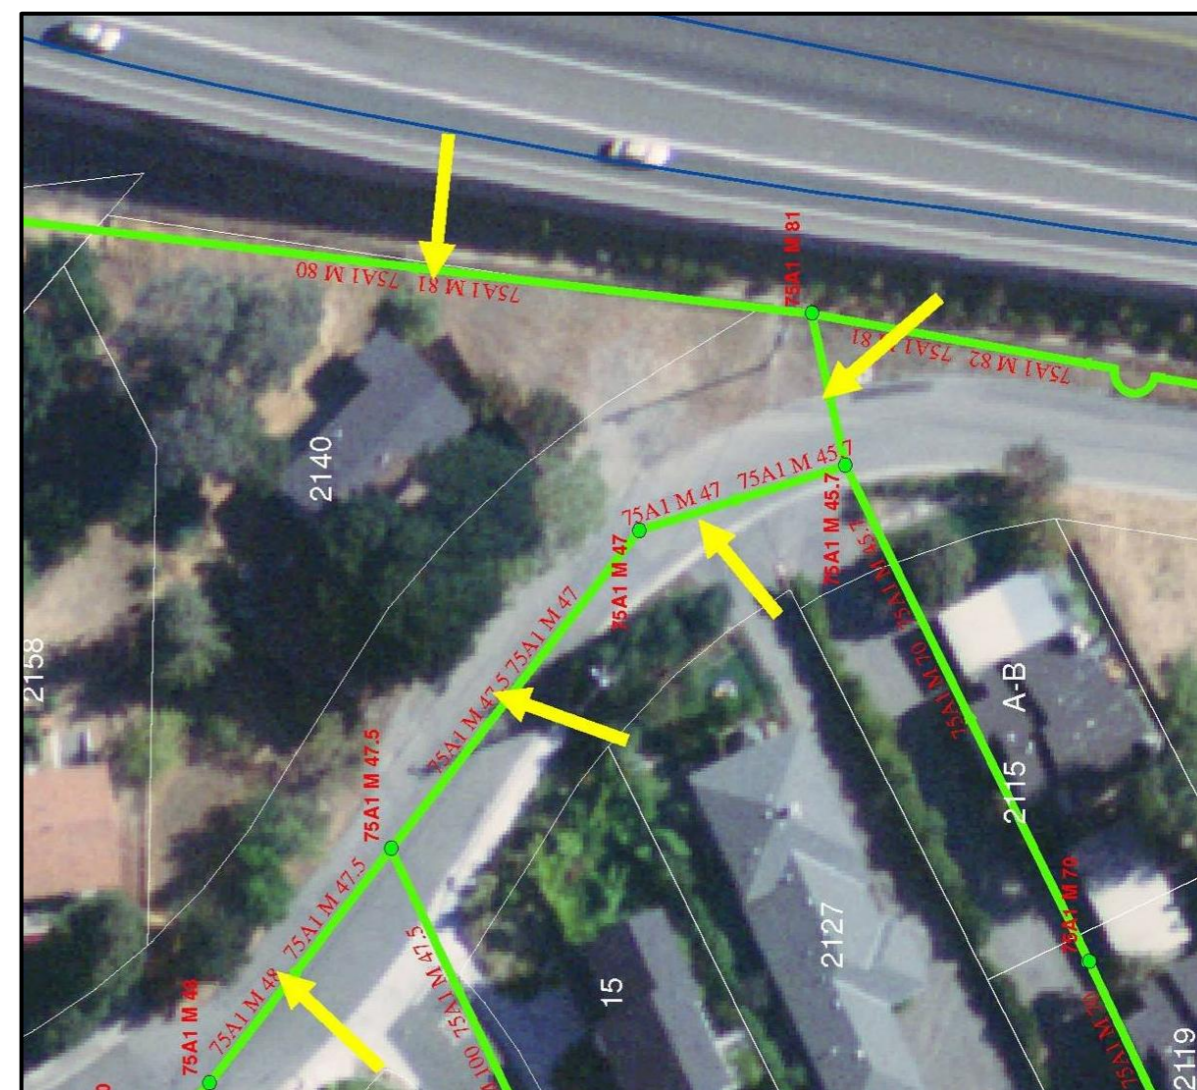
# Residential Plumbing Connection to City Sewers

House with 5 mainline sewers on perimeter

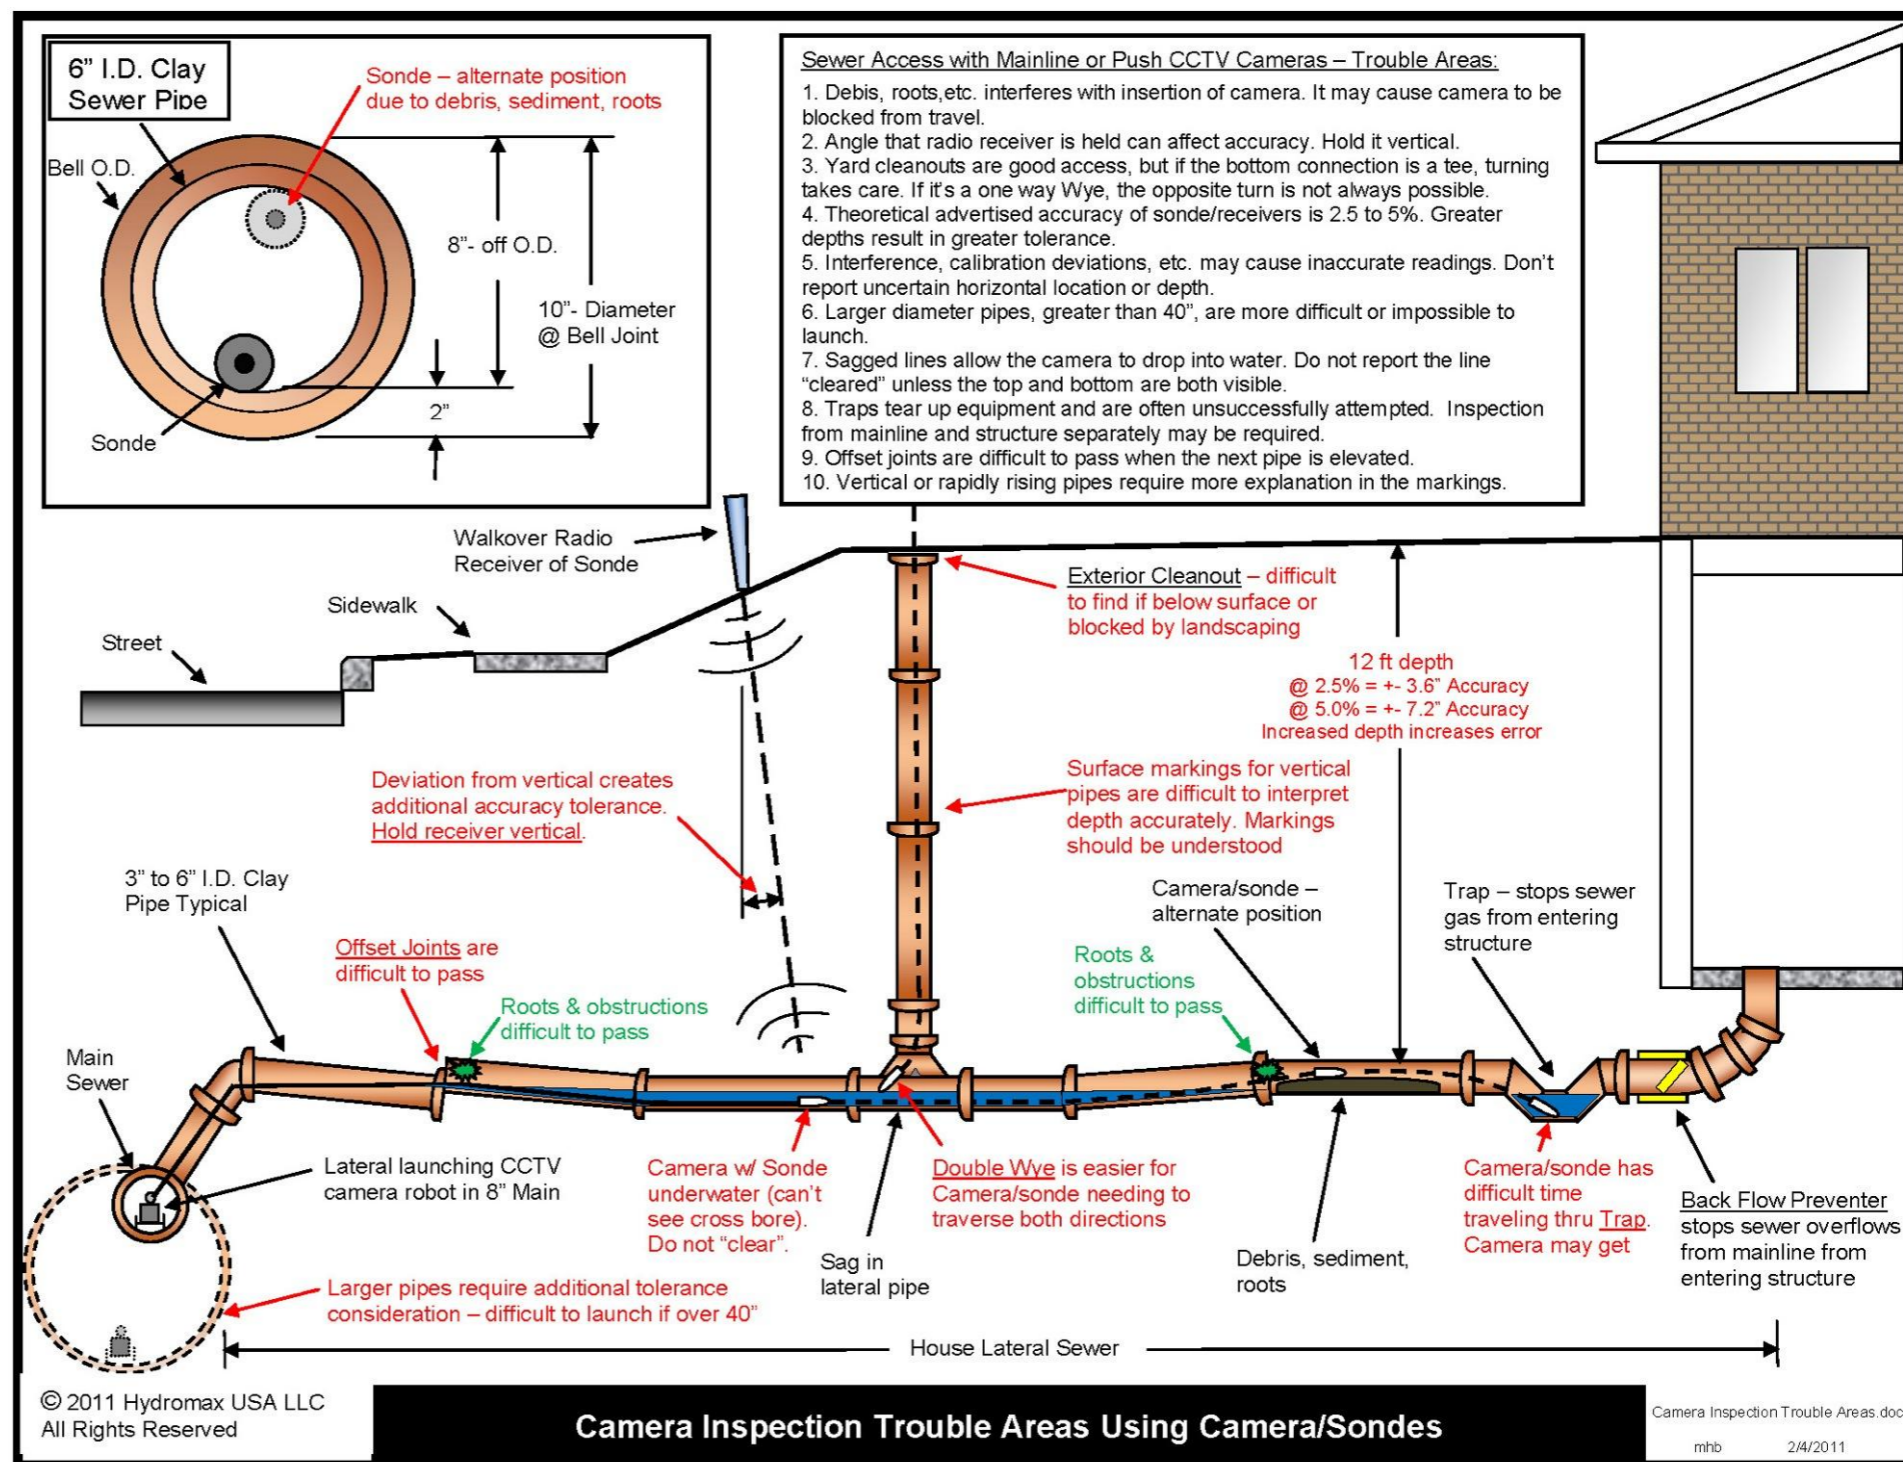
# Camera Inspection Trouble Areas

- Water in sags
- Roots
- Sonde Angle
- Sonde Position
- Traps
- Back flow preventers

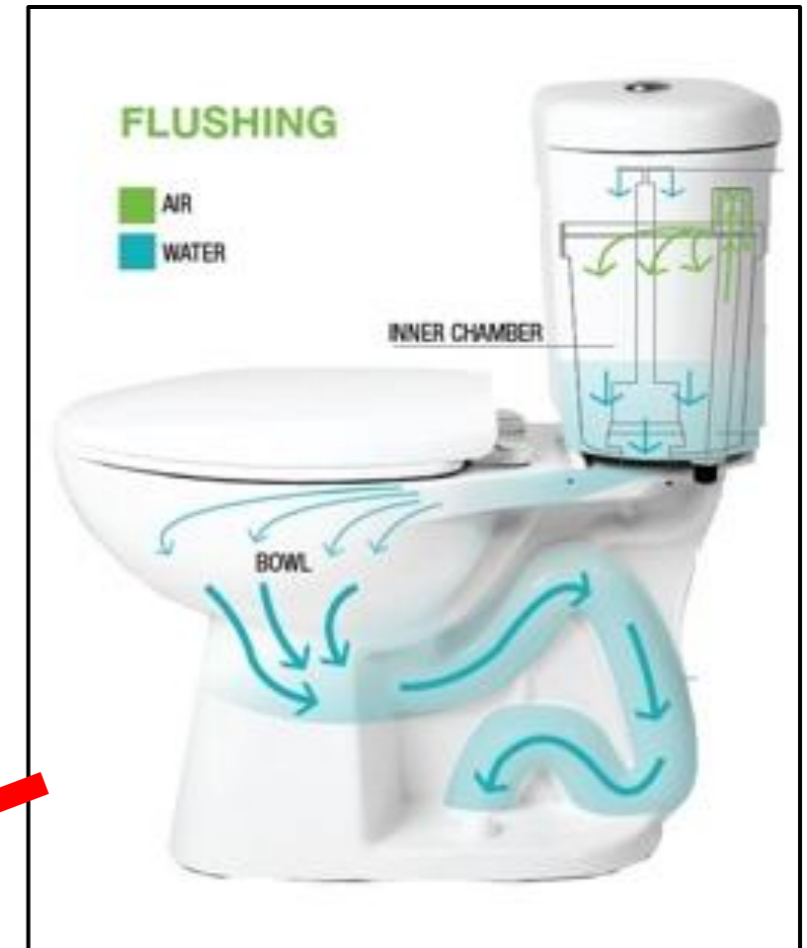
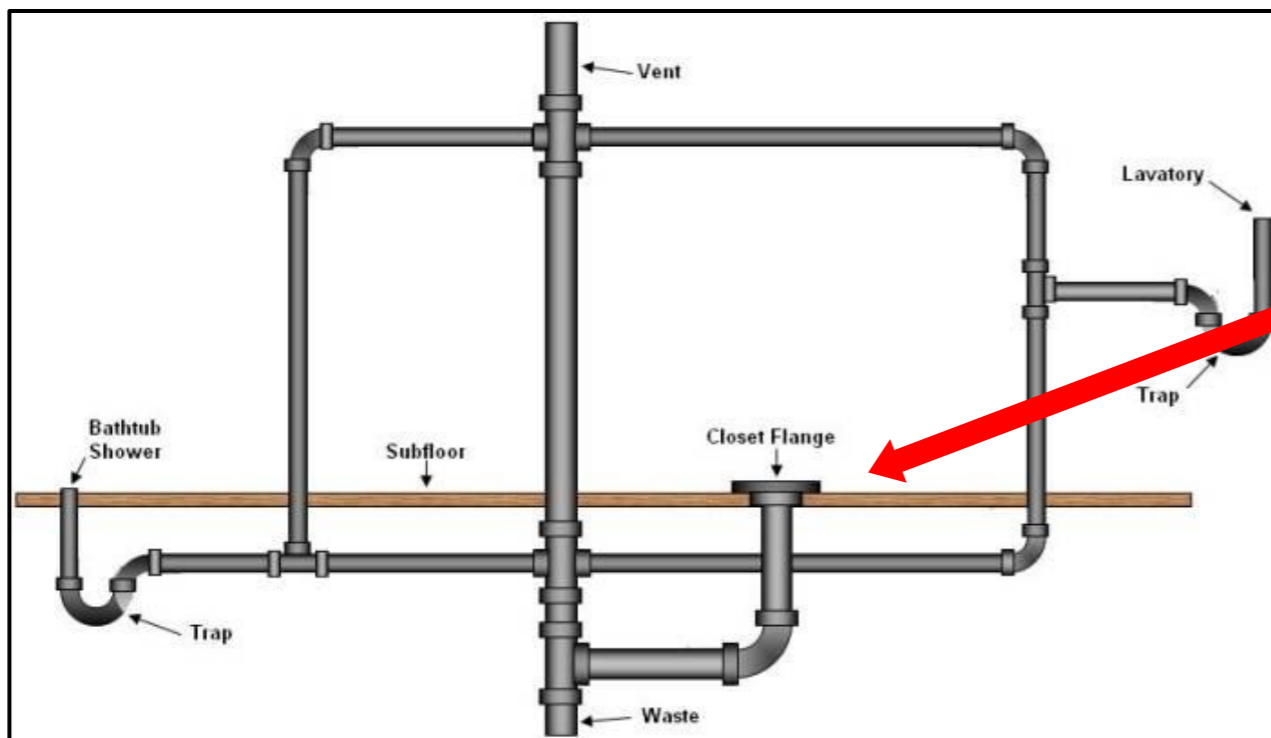
# When Exterior Access is Limited or Pipes Impassable

- Interior access through pipe, roof vents or interior cleanouts
- Permission from owner

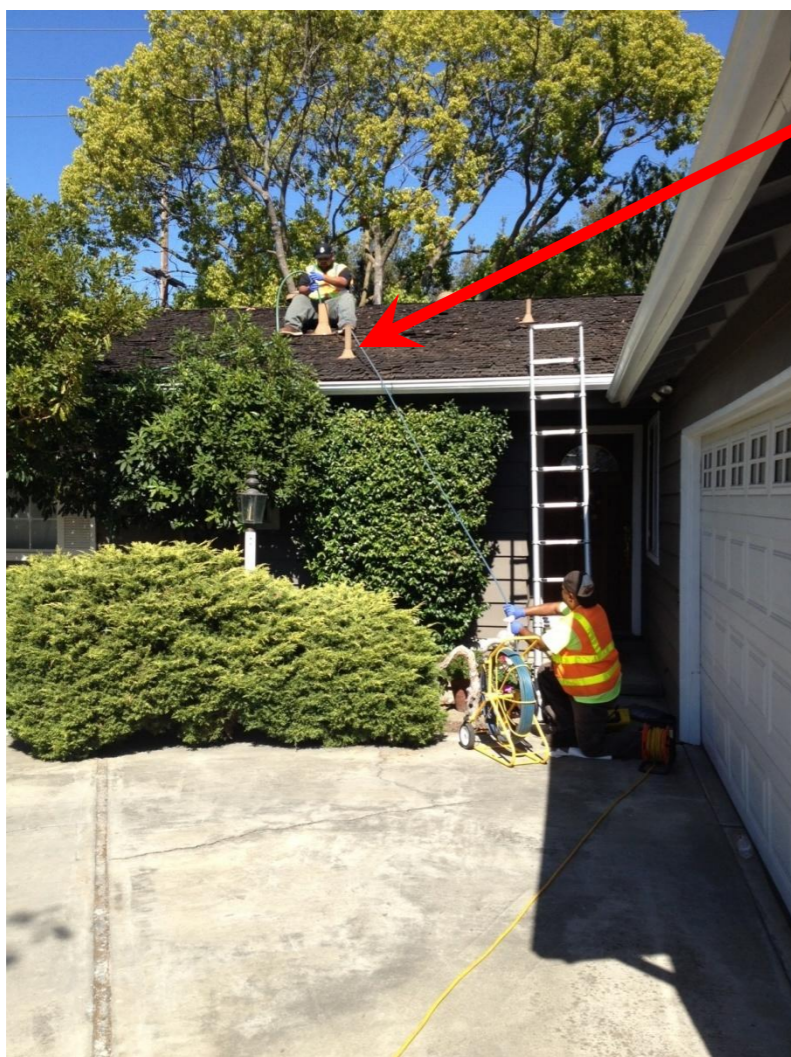
# Roof Vent Access

- Usually only 1 story houses
- Permission from owner
- Protect from falls

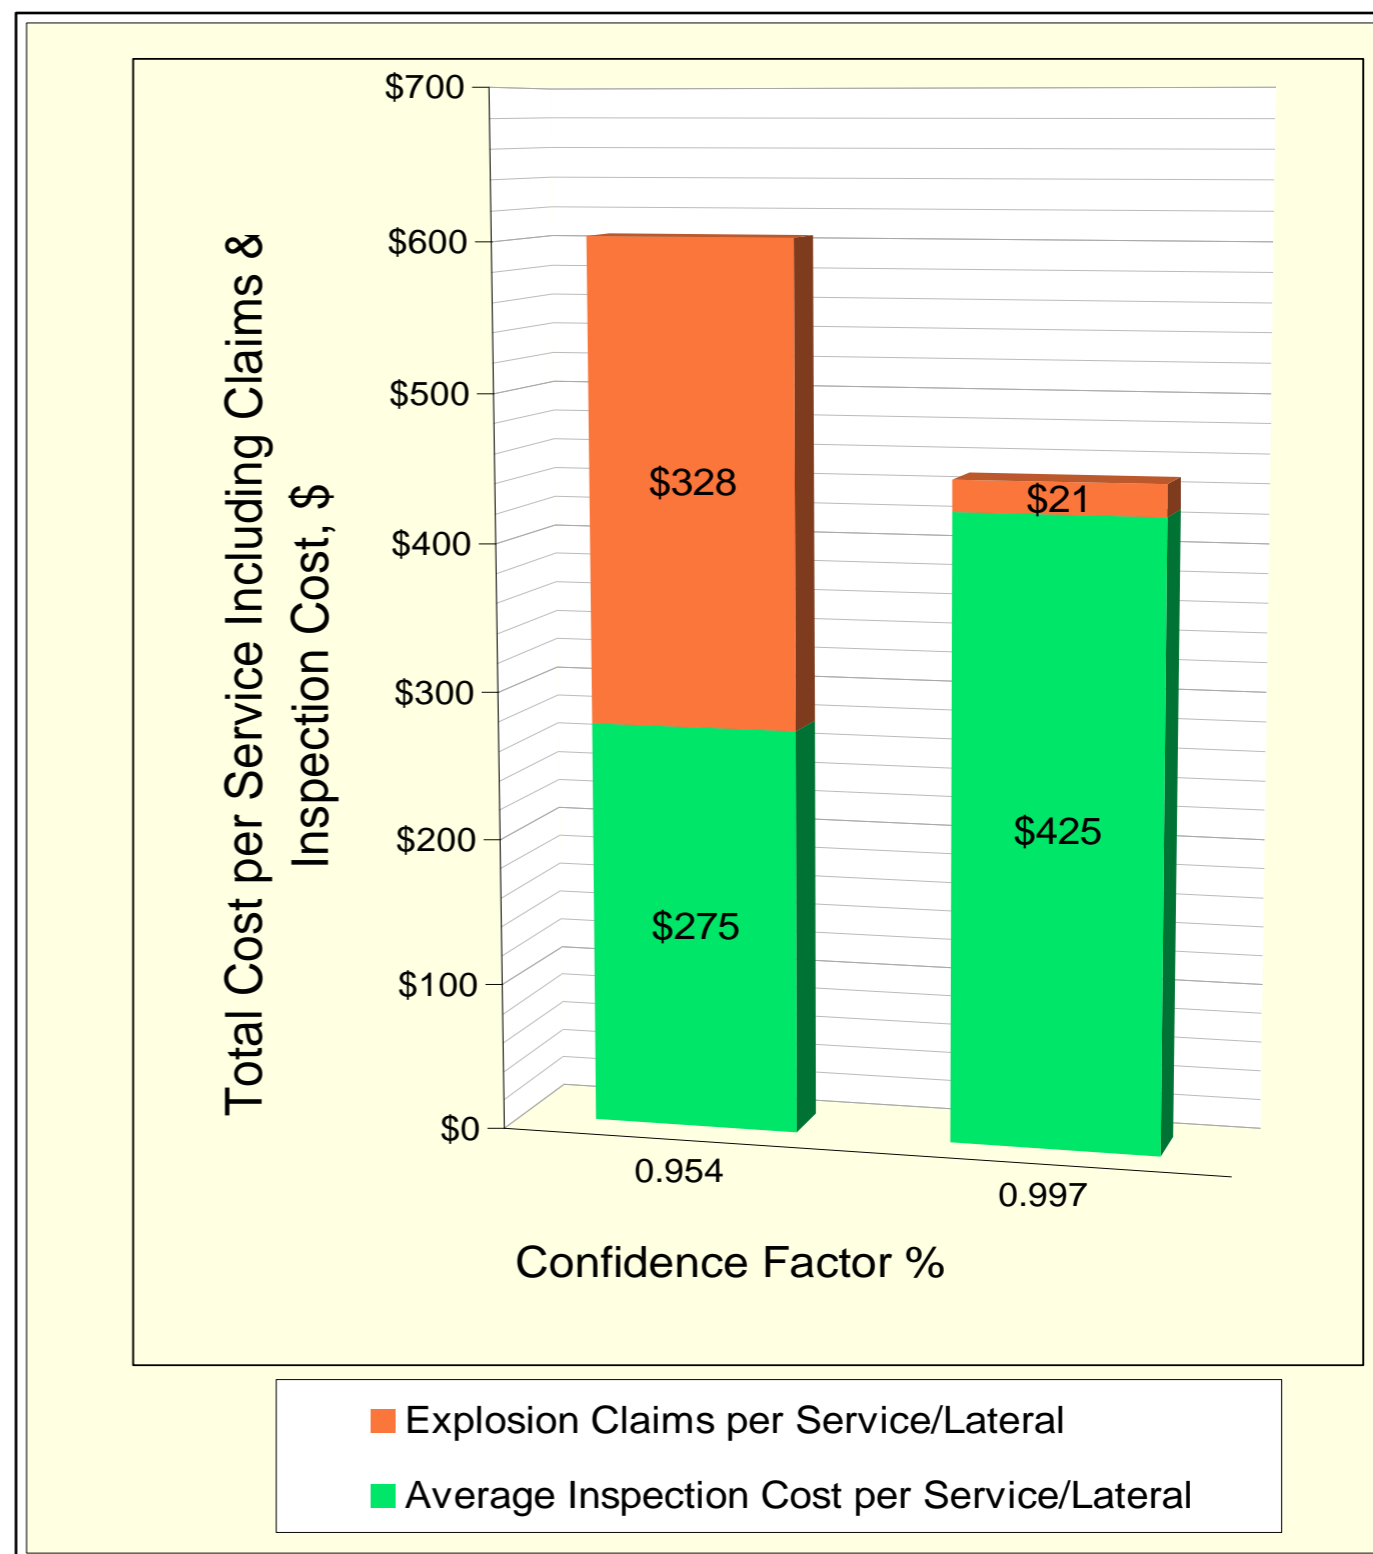
# High Confidence Processes Saves \$

- Net cost of high confidence work is less expensive<sup>1</sup>.
- Higher percentage of explosions from lower confidence processes.
- Net savings = US\$12 Billion
- Less impact on reputation
- Less impact on regulatory rate making process

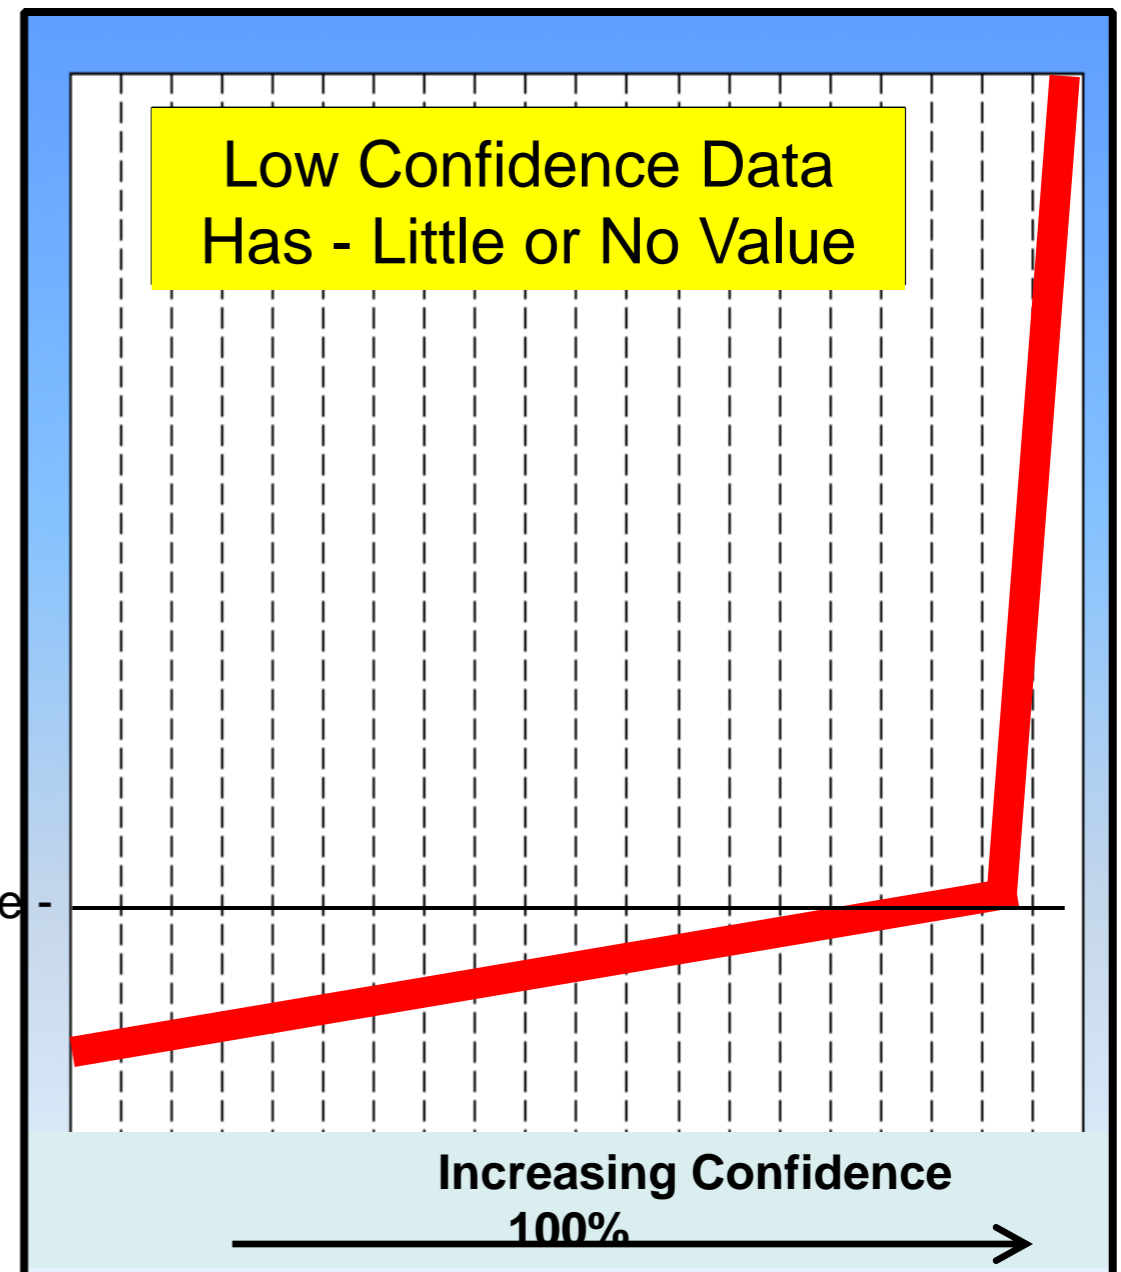
# Value Increases with Higher Confidence Processes

- Low confidence results create false security
- Low confidence results may have negative value
- Low quality work may have to be completely reworked.

100% Value -

0 Value -
