Leading Practices for Cross Bore Risk Reduction

Gas Distribution Safety Focus

By: Mark Bruce, President, Cross Bore Safety Association

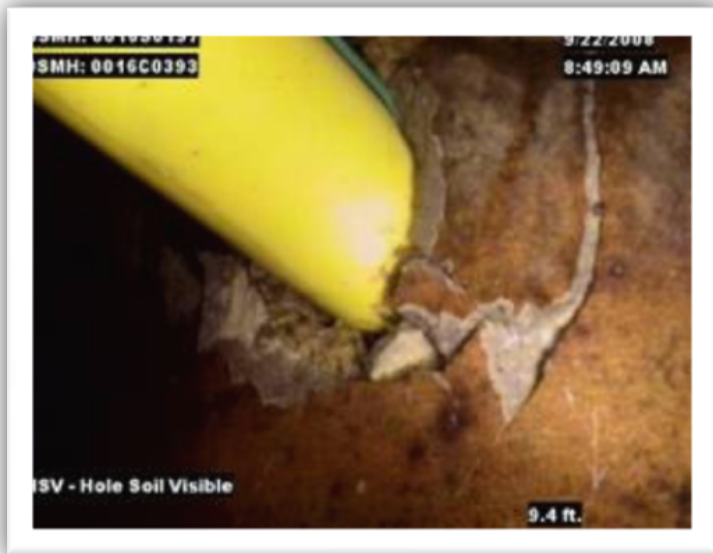
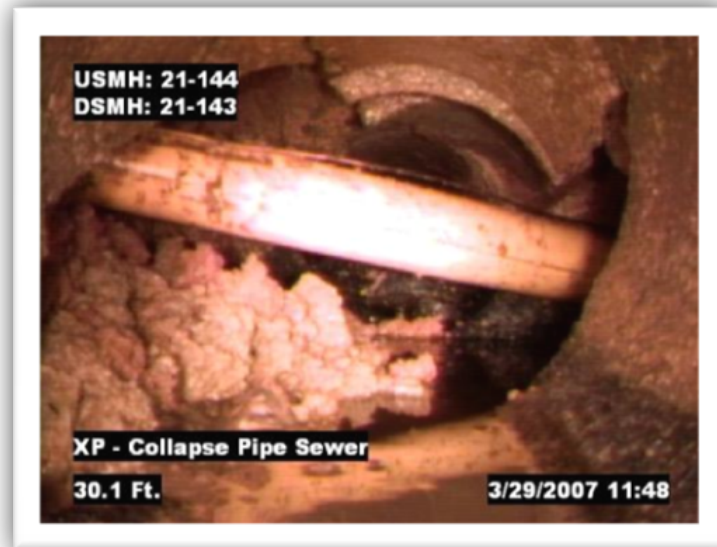
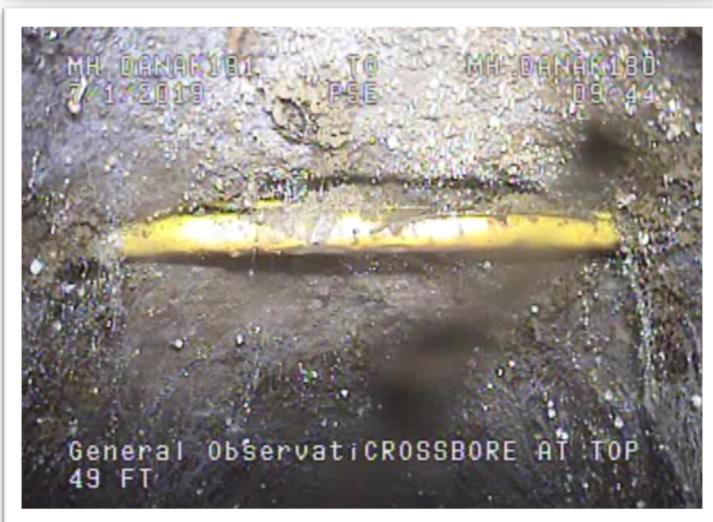
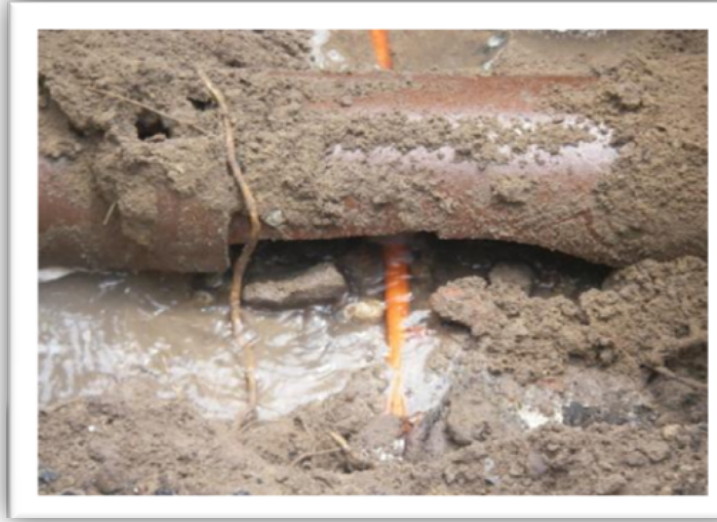
Cross Bores – Class 1, Typically Lays Dormant

One Utility Intersects One Other Utility

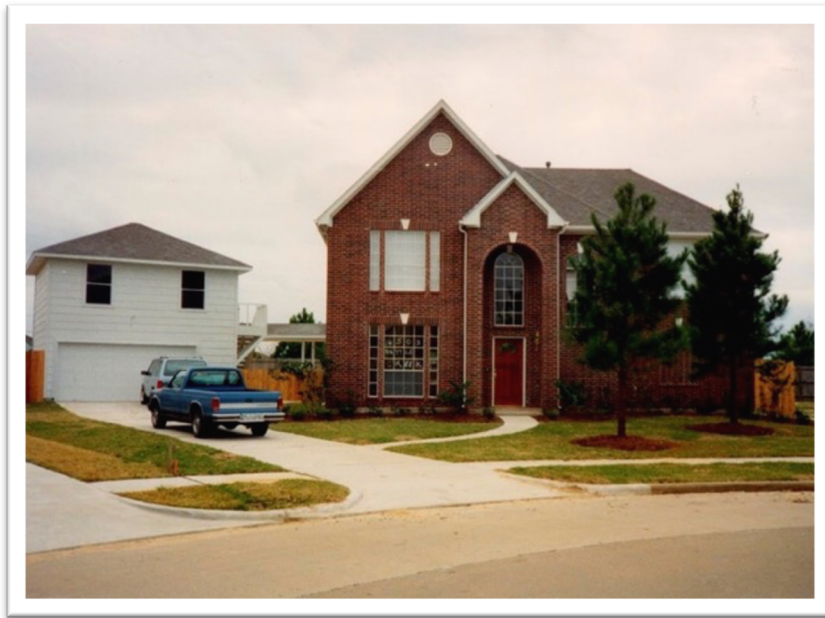
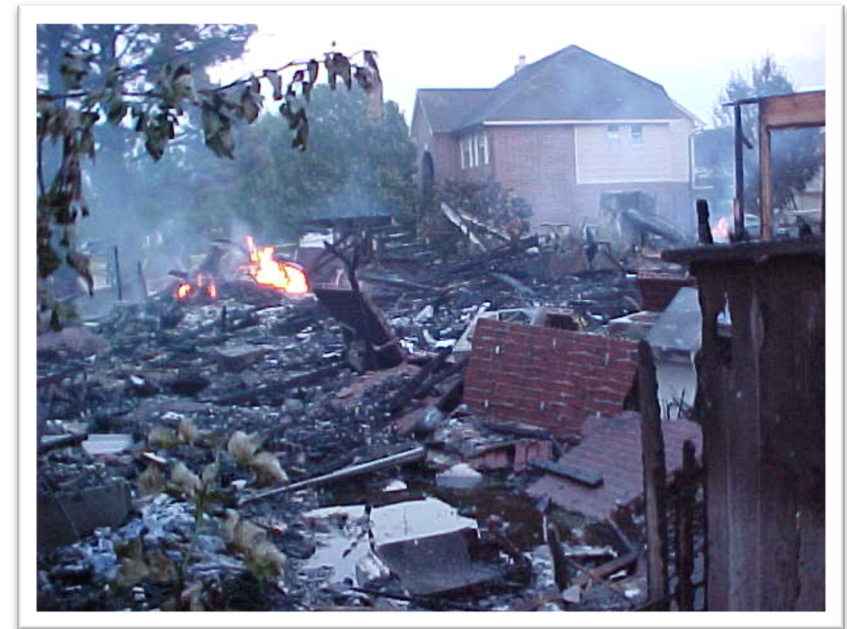
Cross Bore Explosion - Class 2 Cross Bore

(see prior slide of this Class 2 cross bore)

Before

After

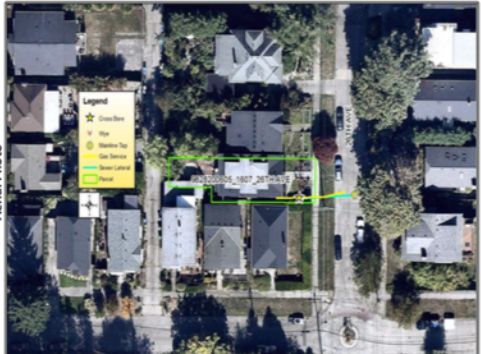
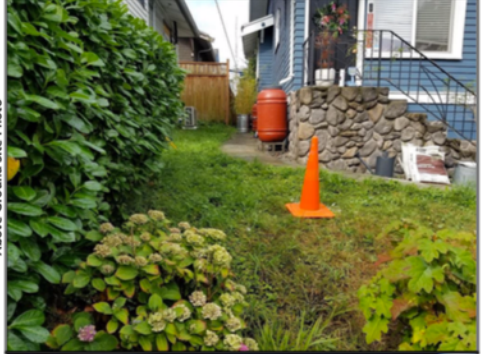
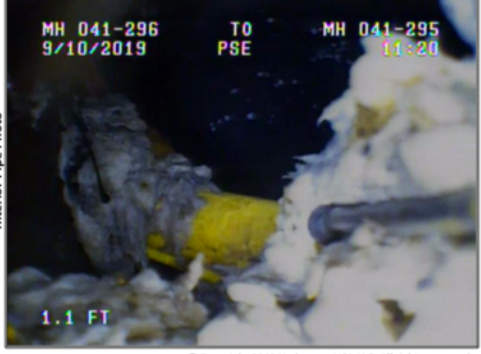
Cross Bore Report	
Date:	9/10/2019
Address:	1607 26th Ave Seattle, WA 98122
Sewer Assets:	
Parcel Number:	9828200605
Claim Number:	186582503
Crew Operator:	Michael Choe
Sewer Asset Type:	Sewer Lateral
Distance from Mainline Tap (for lateral sewer cross bore):	~45'
Distance from Manhole (for main sewer cross bore):	
Sewer Diameter:	6"
Sewer Pipe Material:	Vitrified Clay Pipe
Gas Assets:	
Gas Asset Type:	Service
Gas Line Diameter:	1.125"
Gas Line Material:	PE
Gas Installation SAP:	892607
Gas Installation Date:	4/16/2019
Yrs/Mos Since Install:	0yrs/5mos
Installation Type:	HoleHog
Type of Inspection:	
New Construction	
Cross Bore Type:	
New Construction	
Job Type:	
Simple Service	
Primary Equipment Used:	
Mainline Lateral Launch CCTV	
Additional Equipment Used:	
None	
Additional Notes	
GFR Tim Peterson on site. Wye is ~43.9' from MLT. Cross bore is ~1.1' from beginning of wye

Aerial Photo

Above Ground Site Photo

Interior Pipe Photo
